# MILESTONE INSPECTION REPORT FORMS - STRUCTURAL BSIP INSPECTION FORM

Form EB18 – 2024

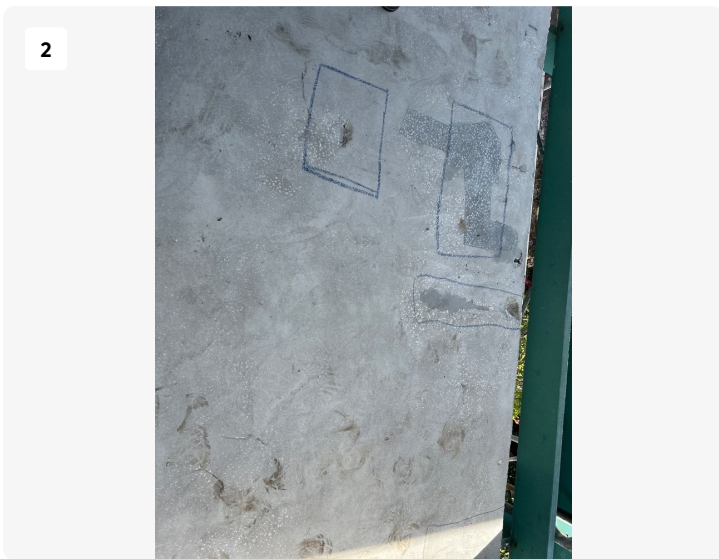
Sounding and marking of balcony deck spalls. Previous repairs visible.

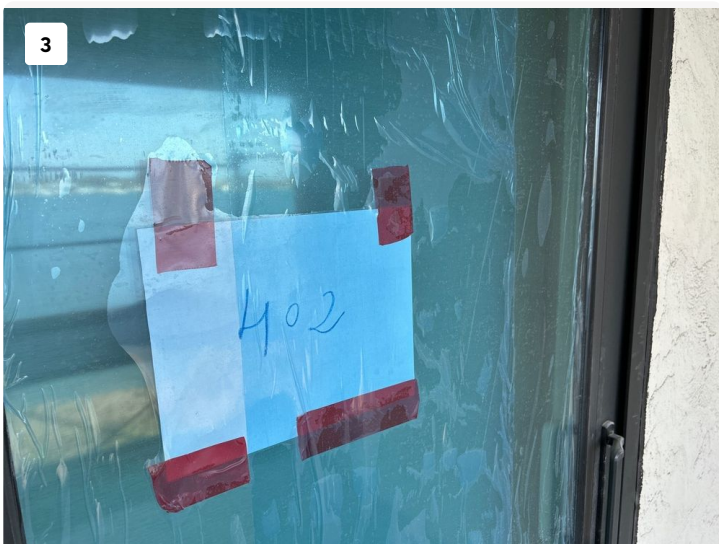
Project: Bridgeport  
Date: 2/28/2024, 3:18pm  
Creator: Matthew Depin

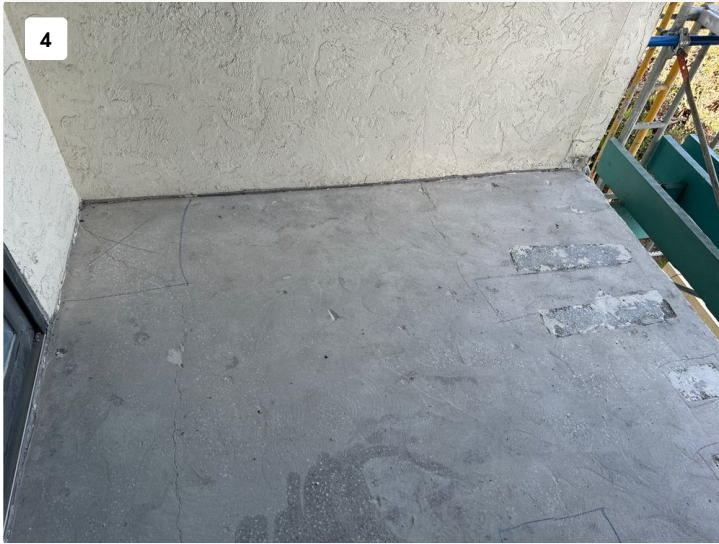
Sounding and marking of balcony deck spalls.

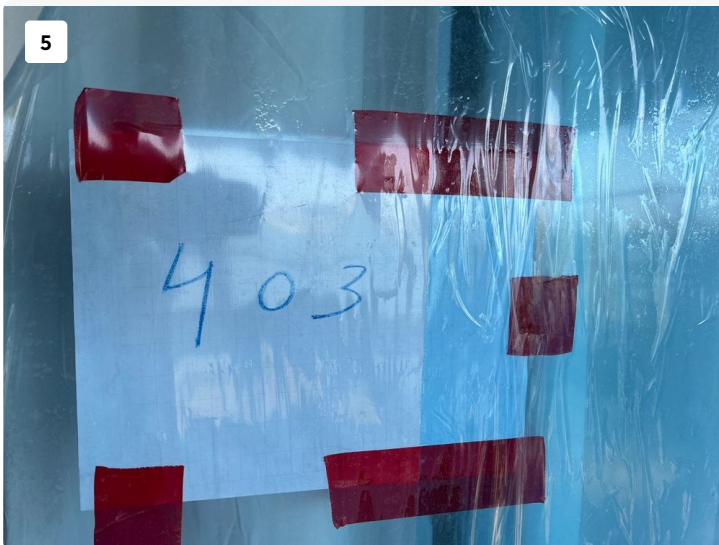
Project: Bridgeport  
Date: 2/28/2024, 3:22pm  
Creator: Matthew Depin

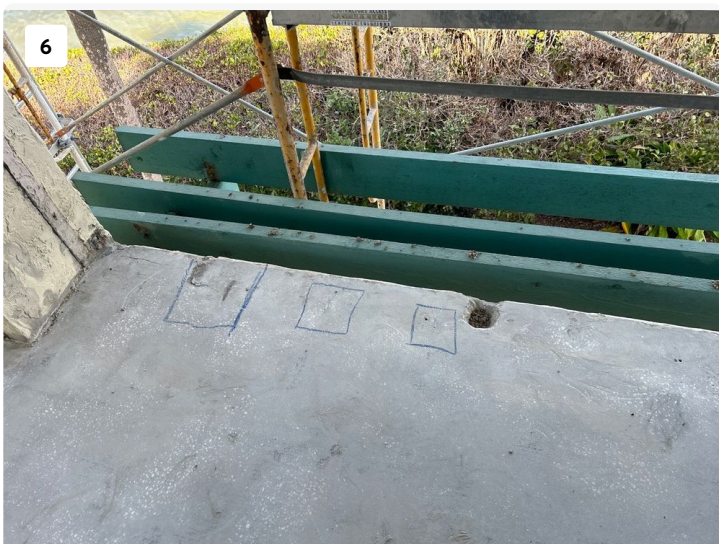
Sounding and marking of balcony deck spalls.

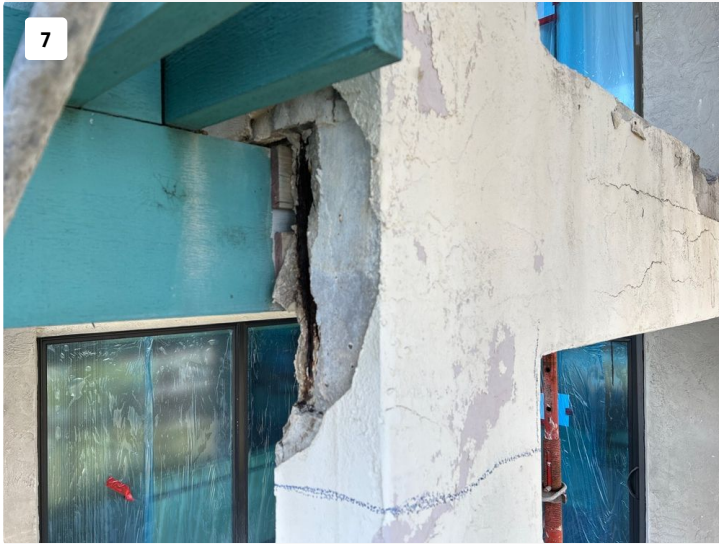
Spall in balcony column behind wood outrigger structure. horizontal spall at edge of balcony.

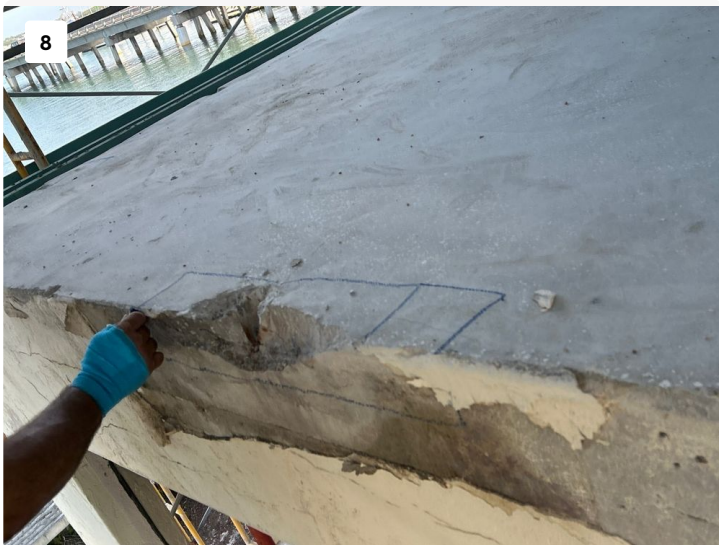
Slab edge spall on balcony.

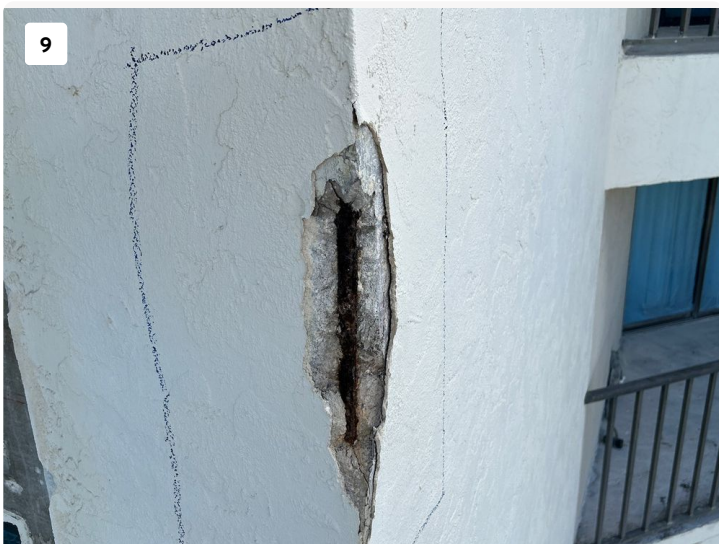
Vertical spall in corner column.

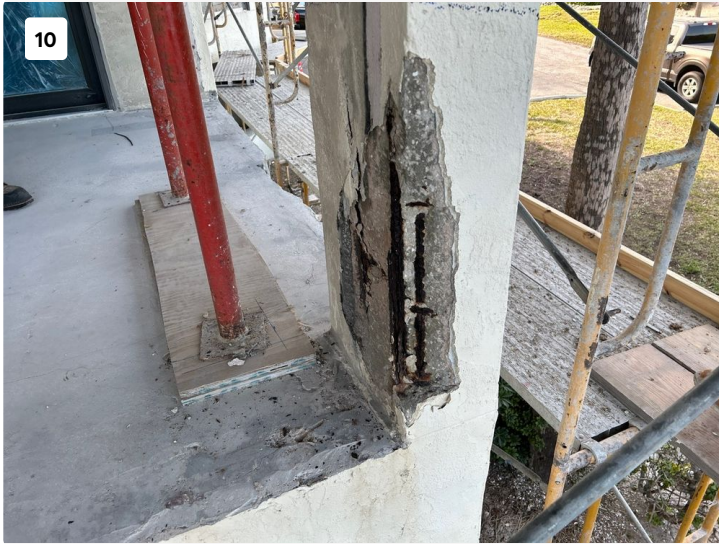
Vertical spall in balcony column.

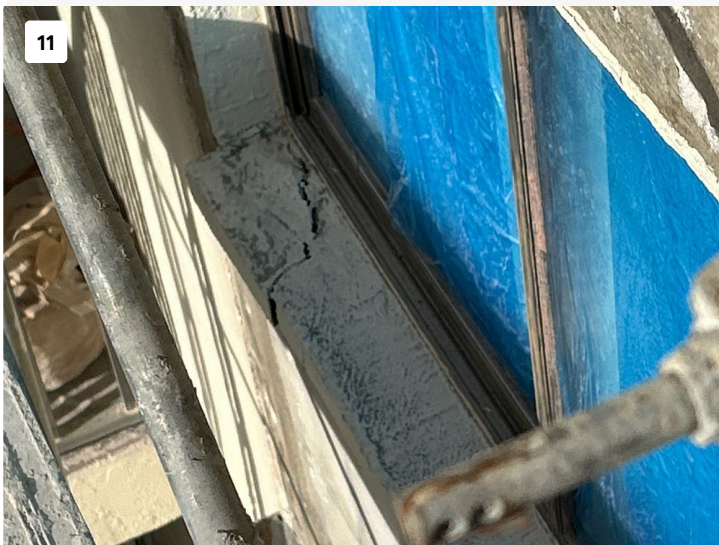
Spall in window sill.

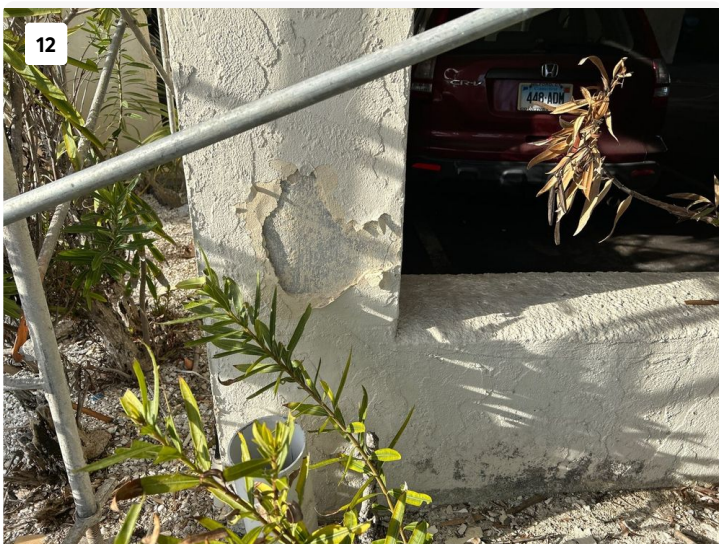
Areas of deteriorated stucco in interior garage walls.

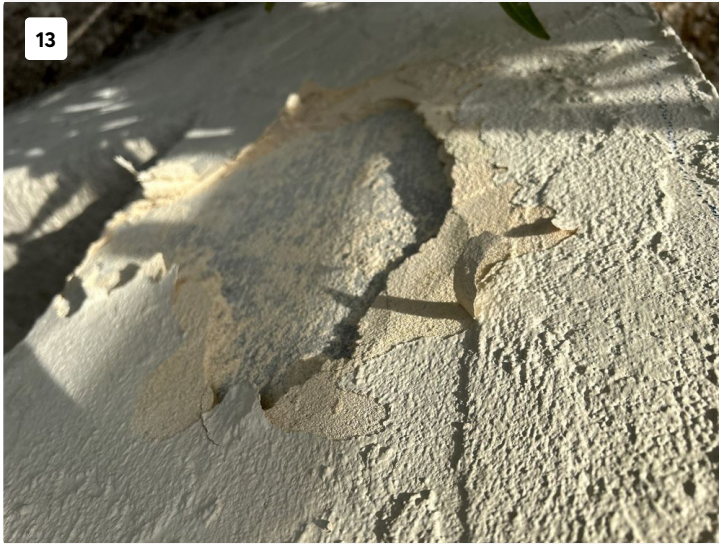
Areas of deteriorated stucco in exterior garage walls.

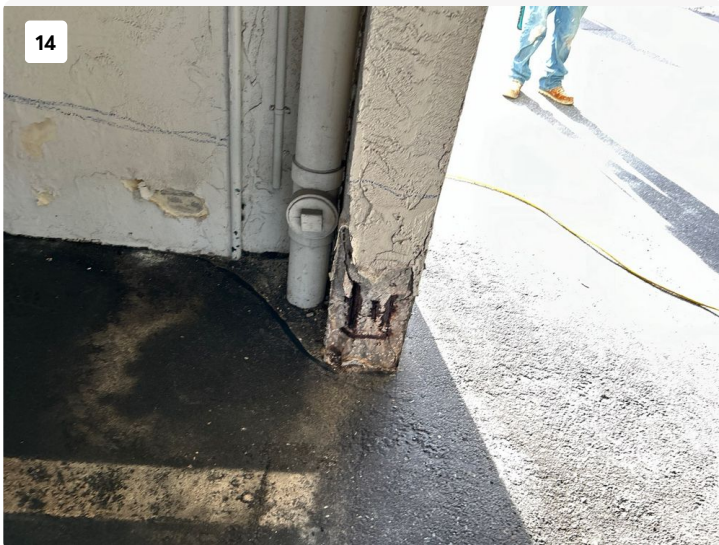
Garage column spall.

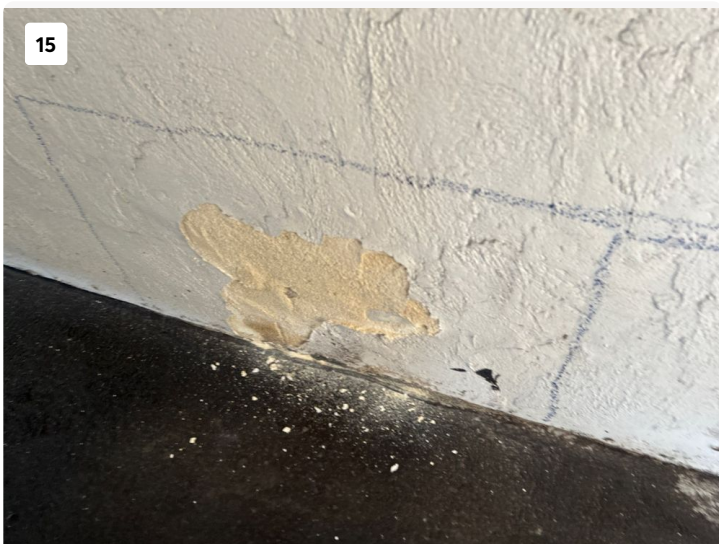
Area of deteriorated stucco in interior garage walls.

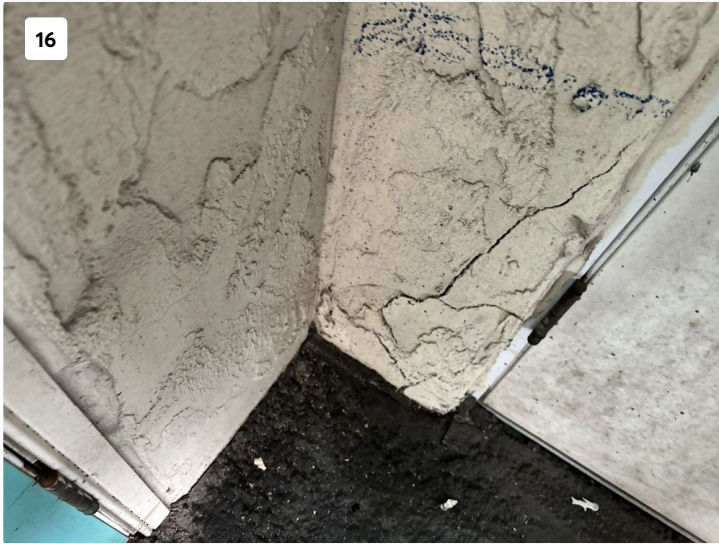
Vertical spall adjacent to garage door.

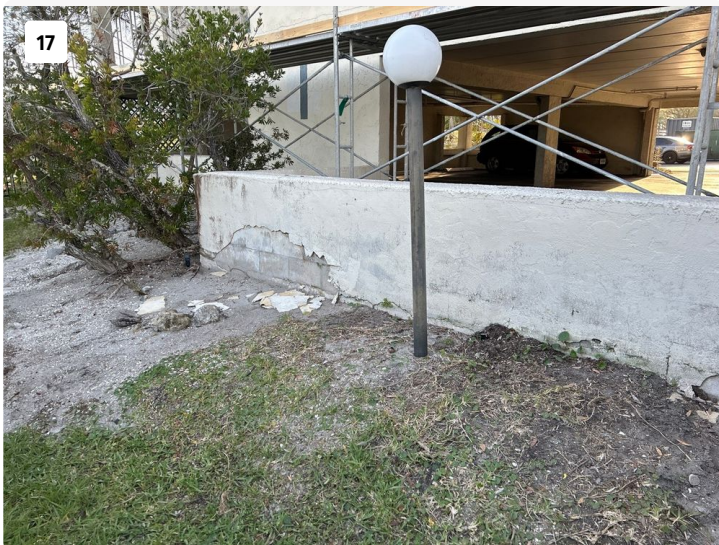
Failed stucco on exterior garage wall.

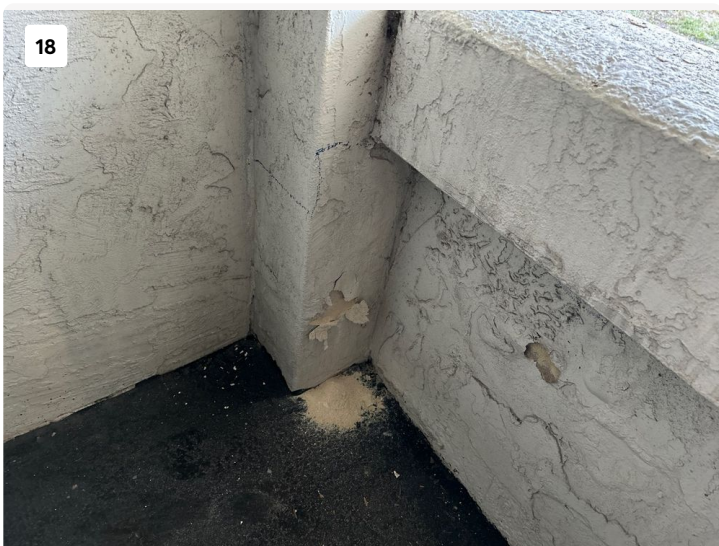
Areas of deteriorated stucco in interior garage walls.

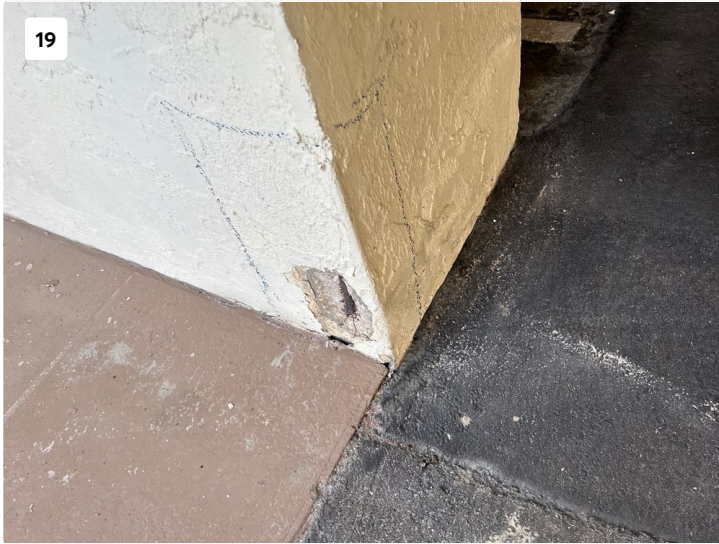
Garage column spall.

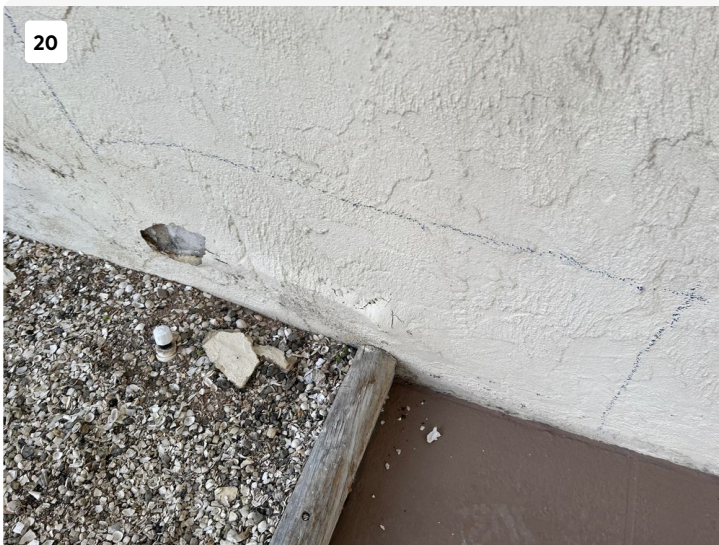
Area of delaminated stucco.

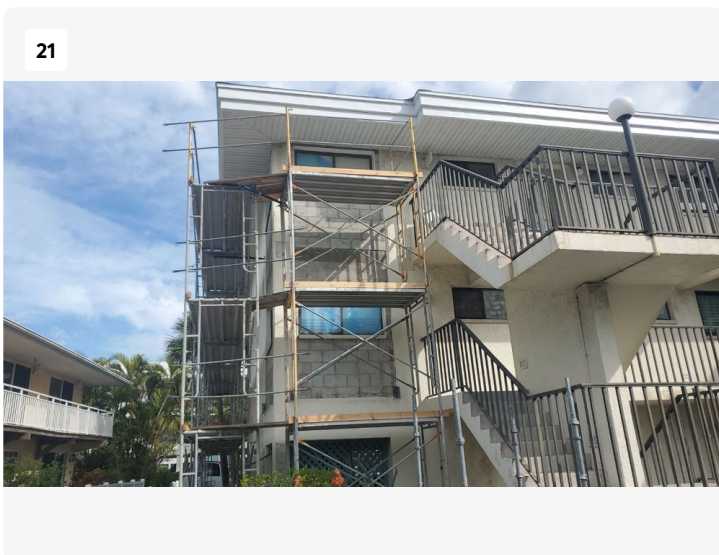
Damaged and rotting wood trim around window opening has been removed.

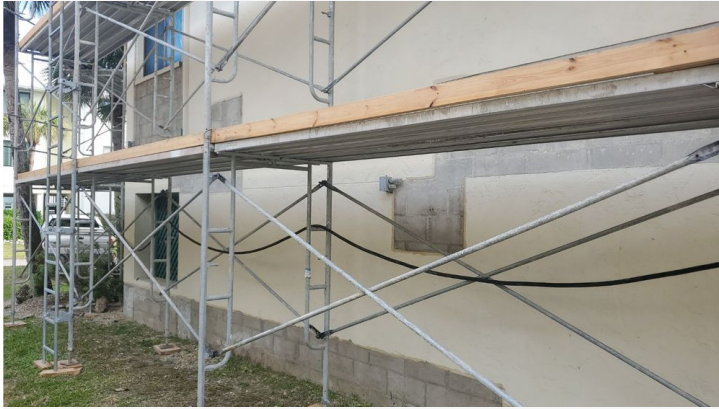
Areas of delaminated or failing stucco removed.

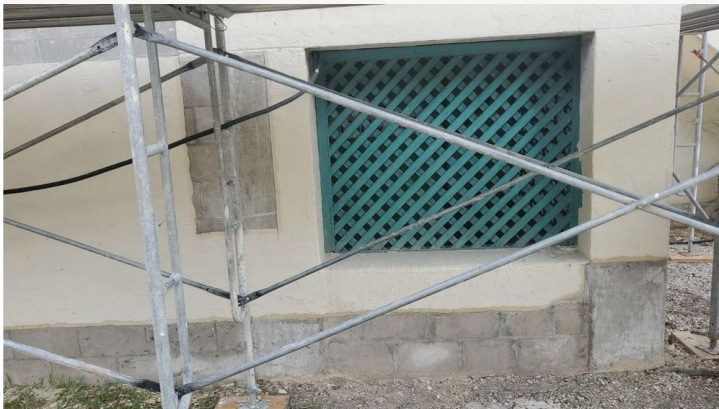
Areas of delaminated or failing stucco removed.

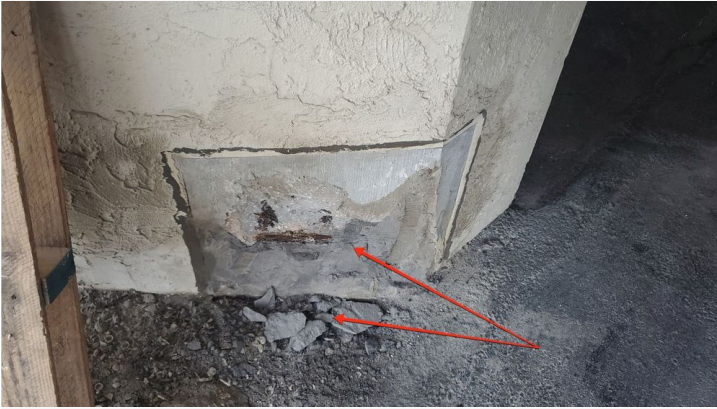
Garage column spall sounded and identified for repair. Evidence of previous repair present.

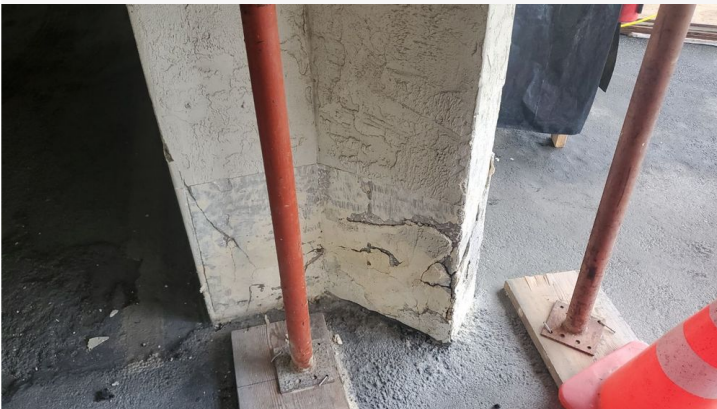
Garage column spall sounded and identified for repair.

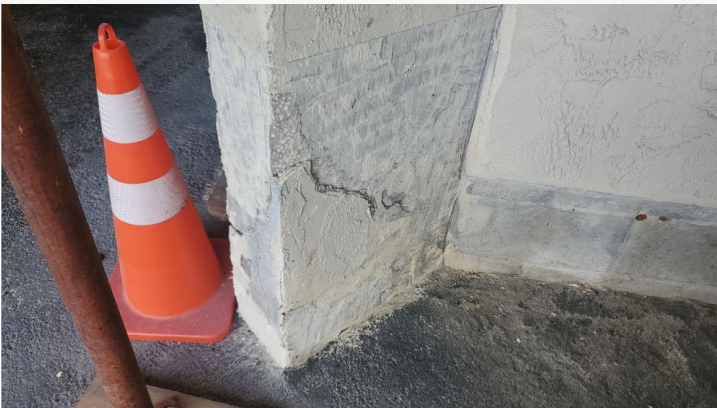
Garage column spall sounded and identified for repair.

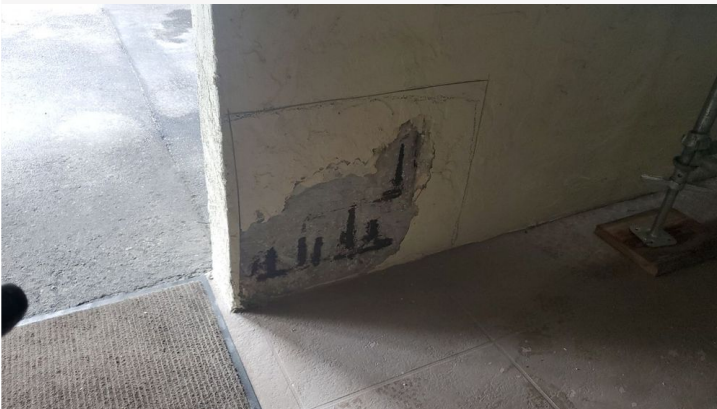
Garage column spall sounded and identified for repair.

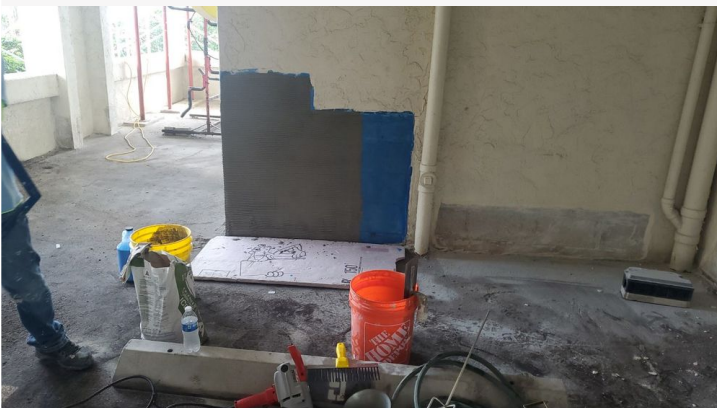
Stucco replacement in progress on garage wall.

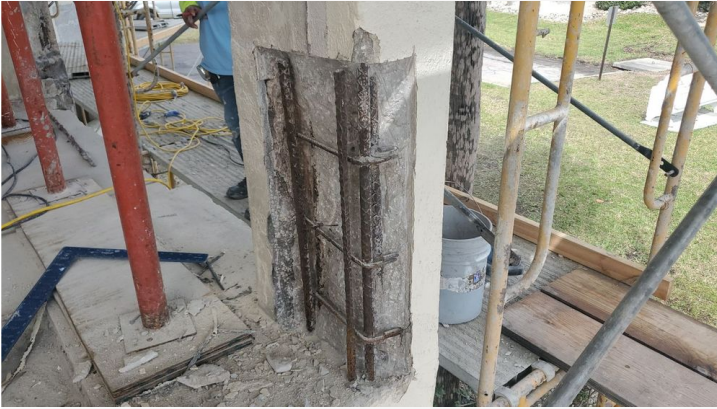
Balcony column repairs in progress.

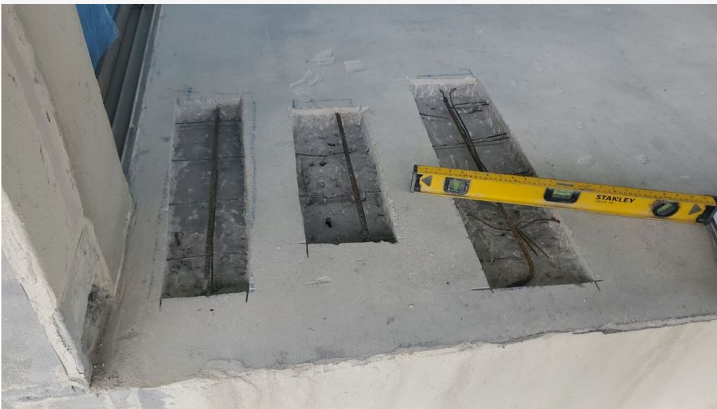
Balcony topping slab repairs in progress.

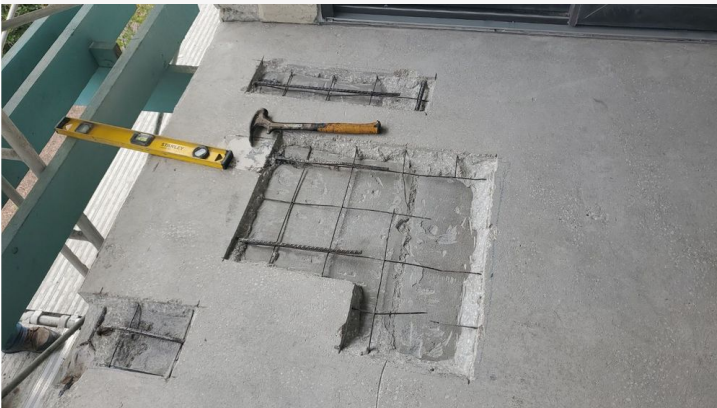
Balcony topping slab repairs in progress.

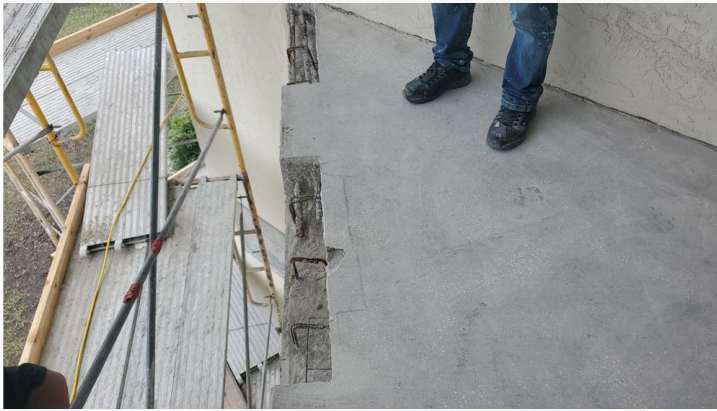
Balcony slab edge concrete repair in progress.

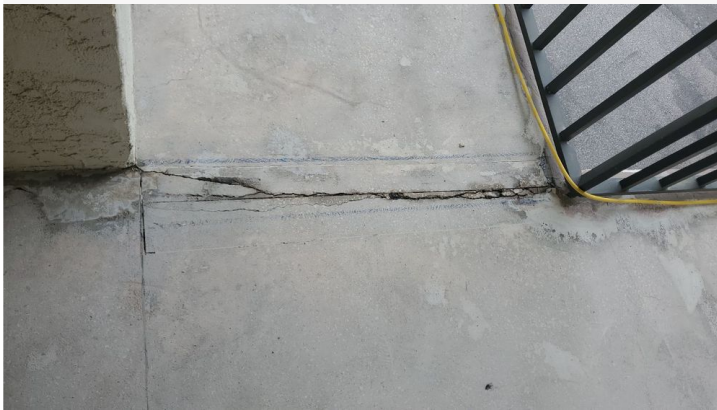
Cracking and previous repair of topping slab at intersection of hollow core panels on walkway.

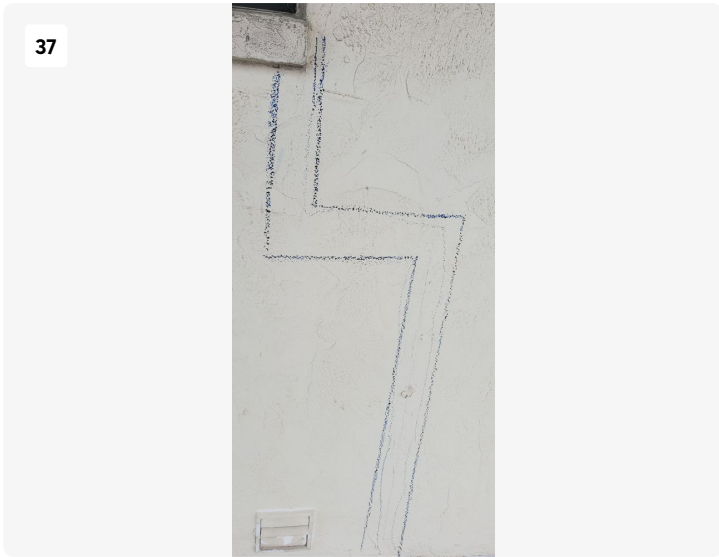
Project: Bridgeport  
Date: 3/6/2024, 1:26pm  
Creator: Teddy Watkins

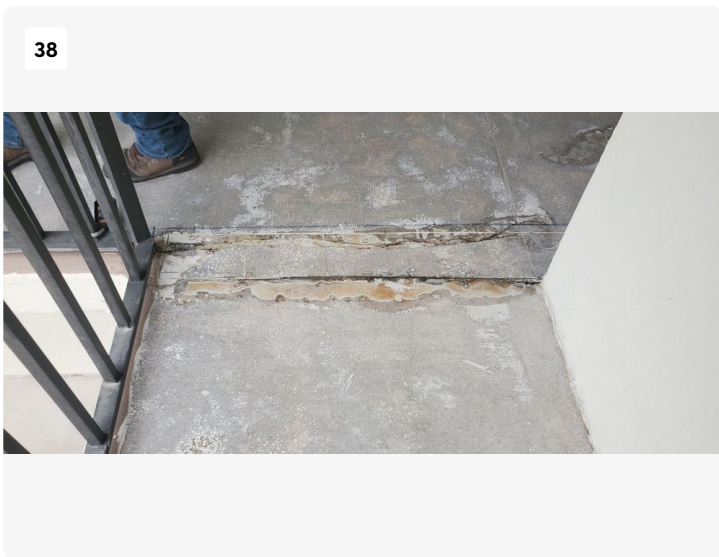
Cracking and previous repair of topping slab at intersection of hollow core panels on walkway.

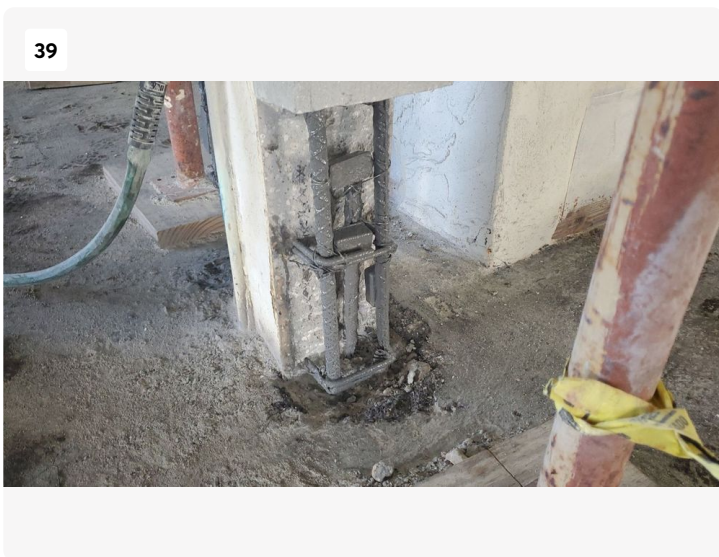
Garage CIP column repair in progress. Reinforcing rebar coated with armatec cementitious epoxy resin with corrosion inhibitors.

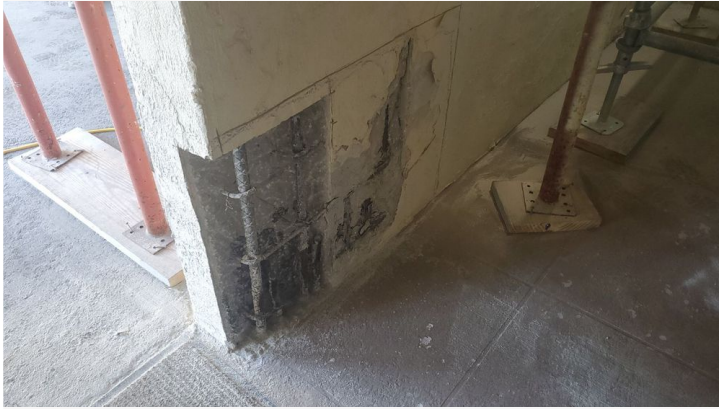
Garage column repair in progress.

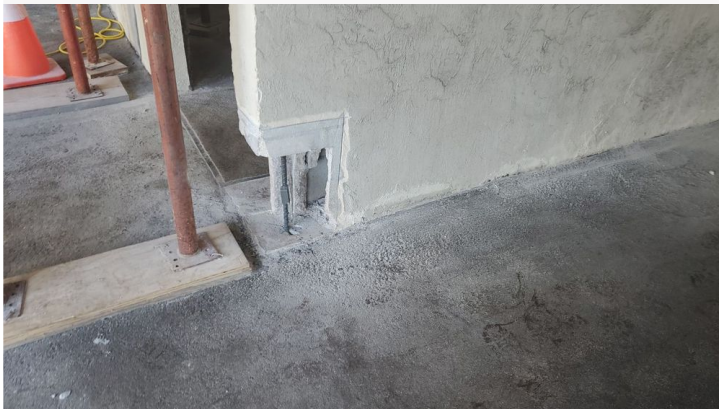
Garage filled cell repair in progress. Reinforcing rebar coated with armatec cementitious epoxy resin with corrosion inhibitors.

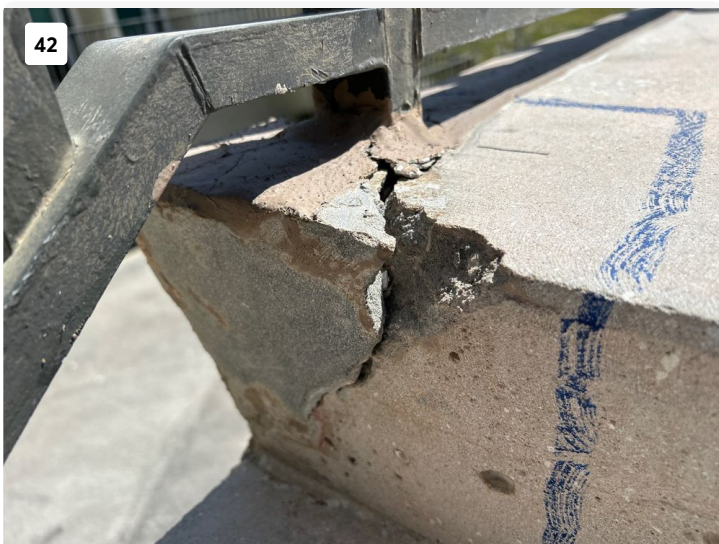
Failed post pocket and existing railing.

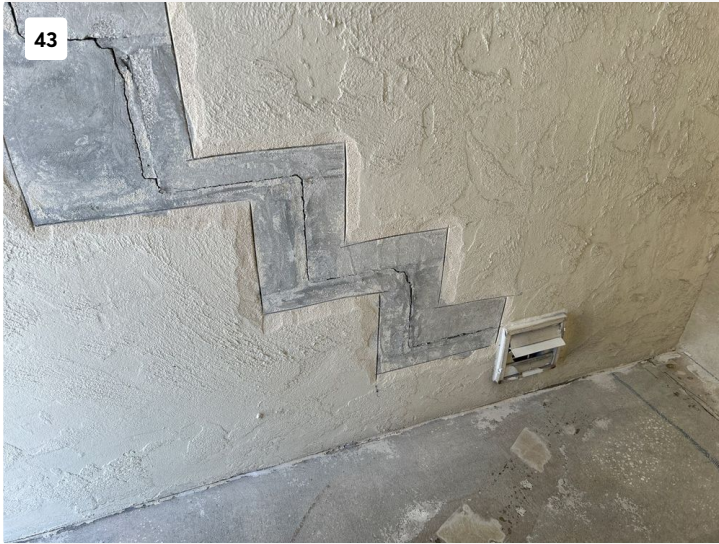
Stucco repair around stair step crack.

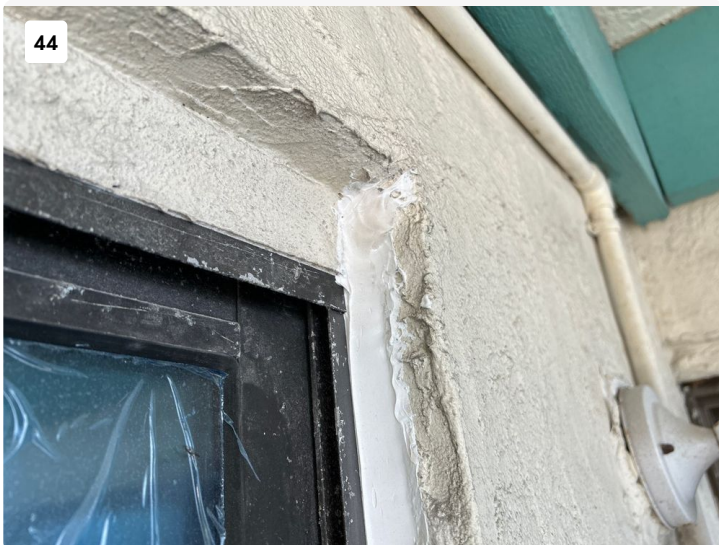
New balcony sliding glass door opening sealant.

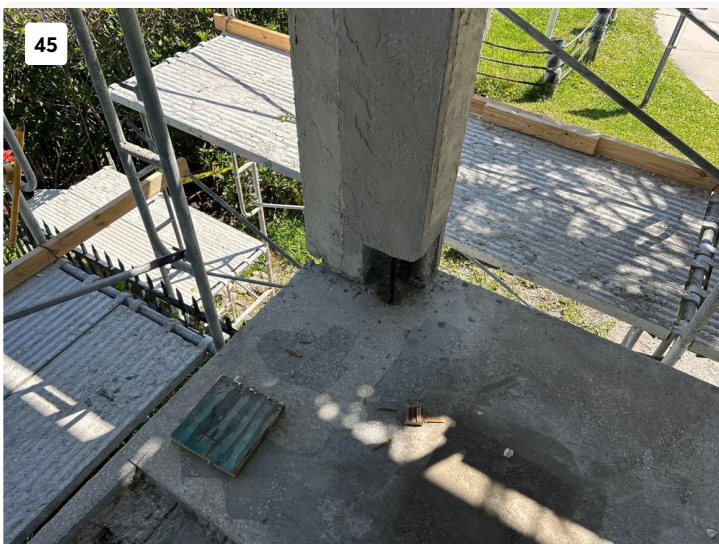
Balcony column spall repair in progress.

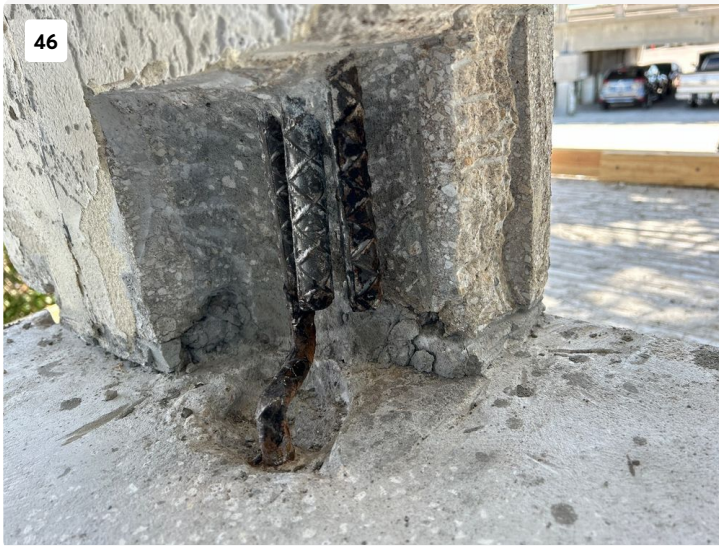
Balcony column spall repair in progress.

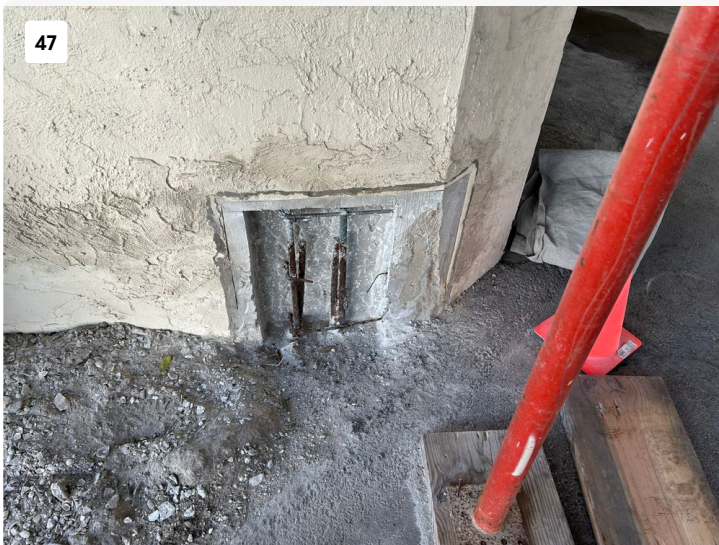
CIP garage column spall repair in progress.

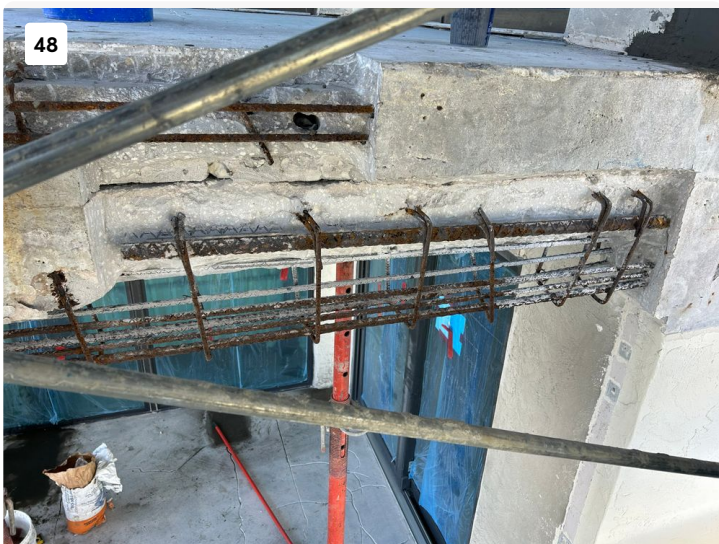
Balcony beam repair in progress.

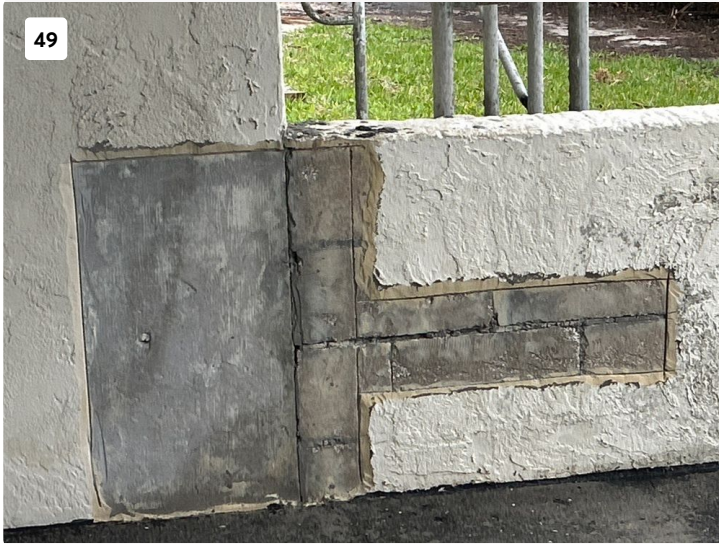
Delaminated stucco removed at intersection of CIP column and CMU block knee wall.

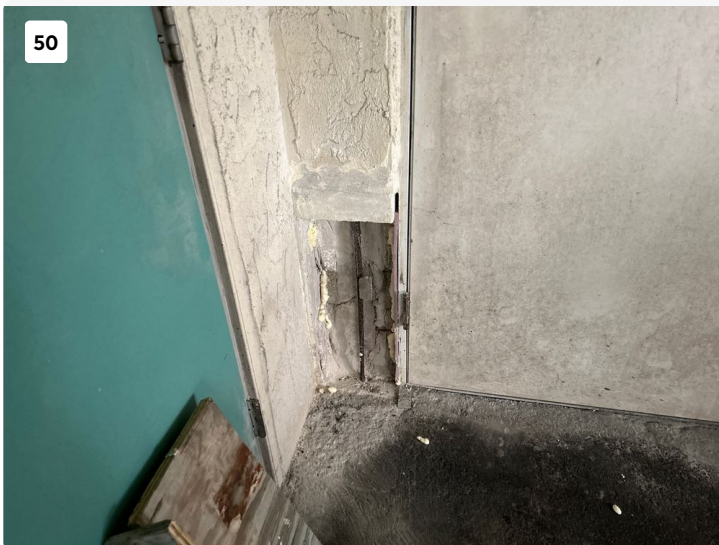
Concrete spall repair in progress. Sacrificial anode placed on reinforcing.

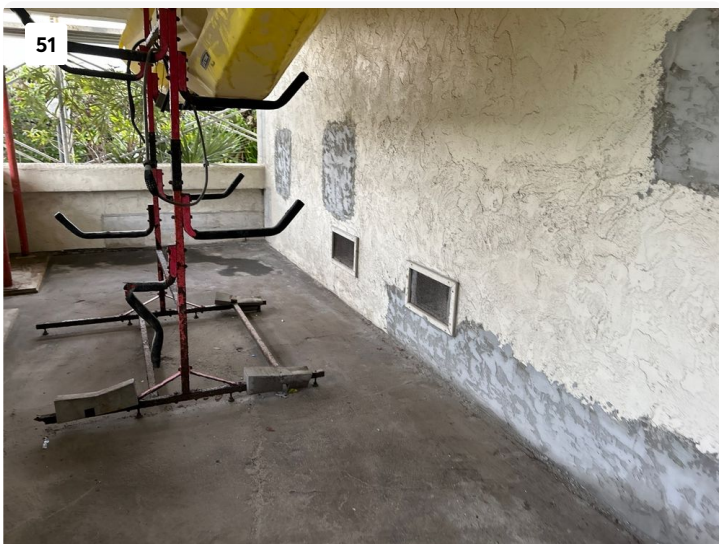
Garage stucco replacement in texture phase.

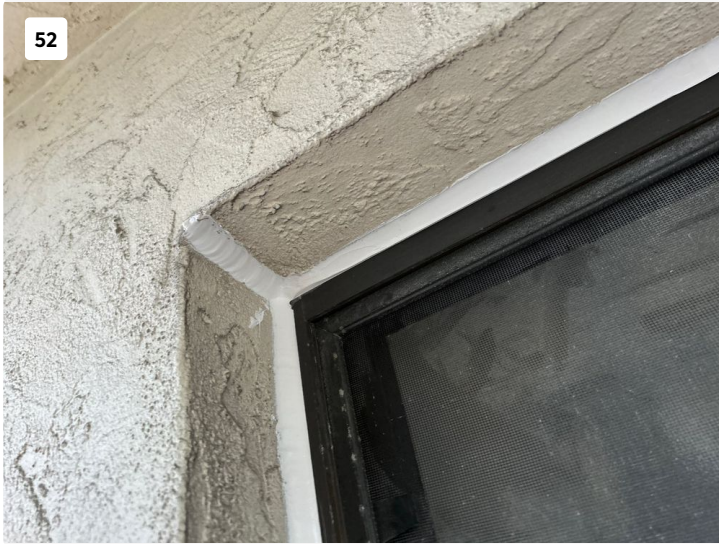
New window opening sealant.

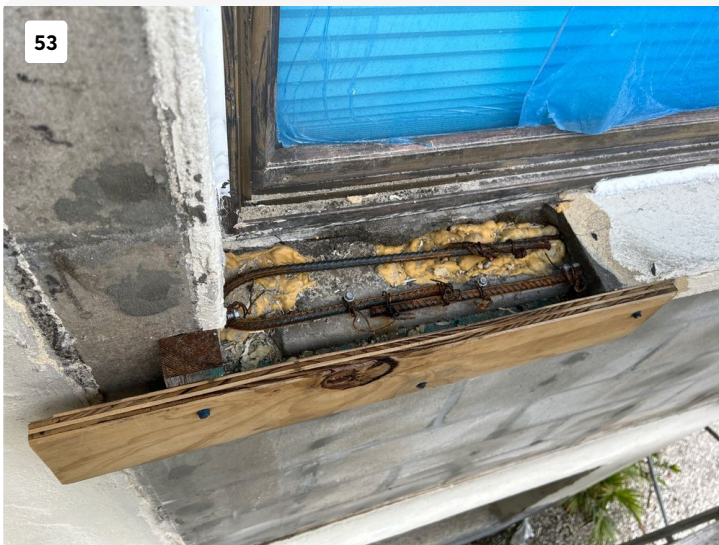
Window sill repair in progress.

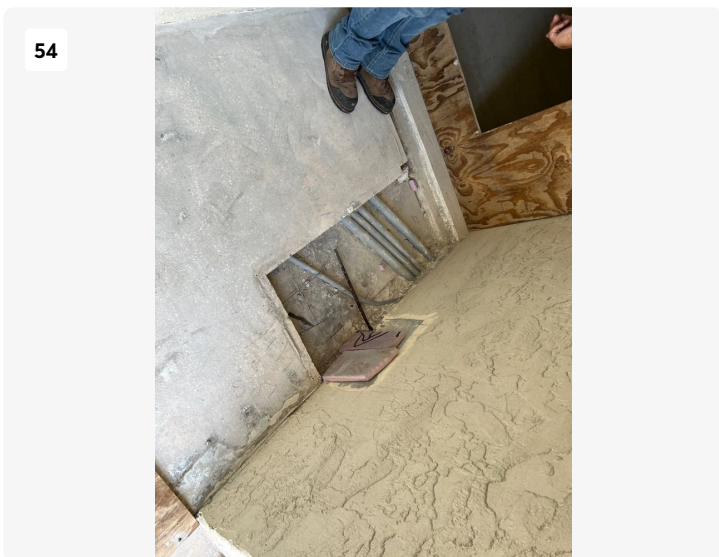
Electrical conduit in walkway topping slab.

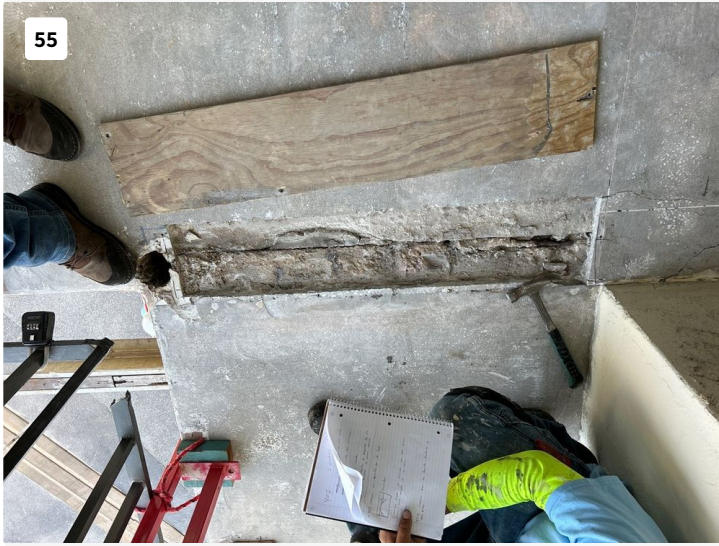
Cracking through topping slab at intersection of hollow cor panels on walkway.

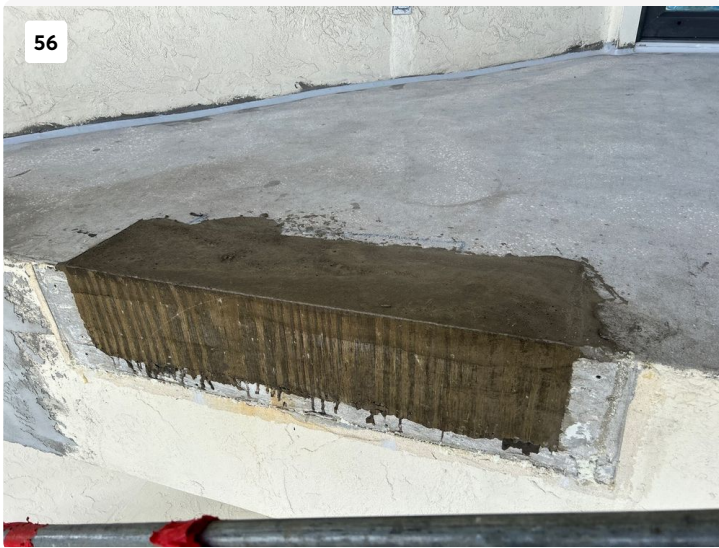
Slab edge concrete repair.

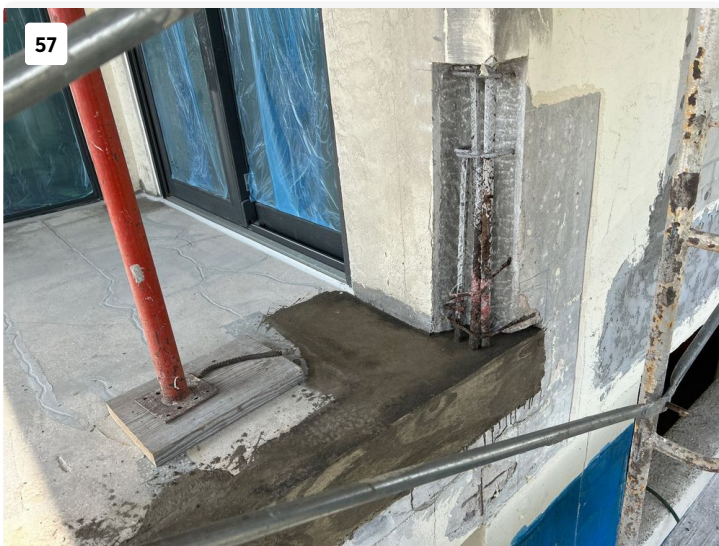
Completed balcony slab edge concrete repair and in progress vertical concrete repair.

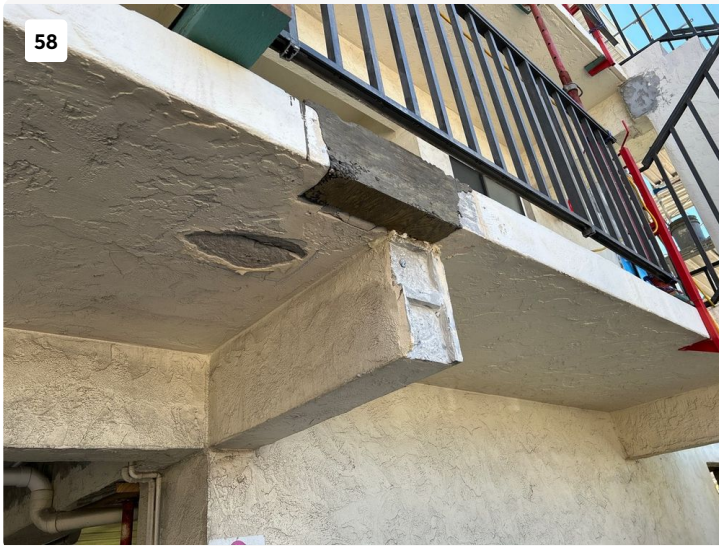
Slab edge concrete repair.

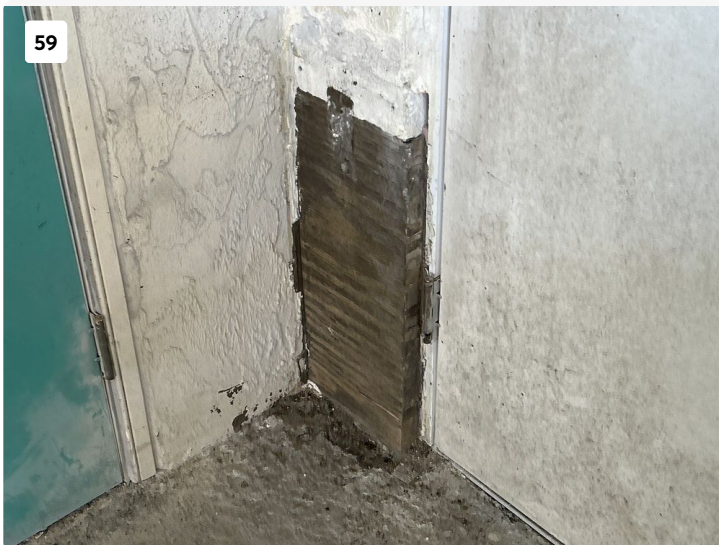
Concrete repair in garage.

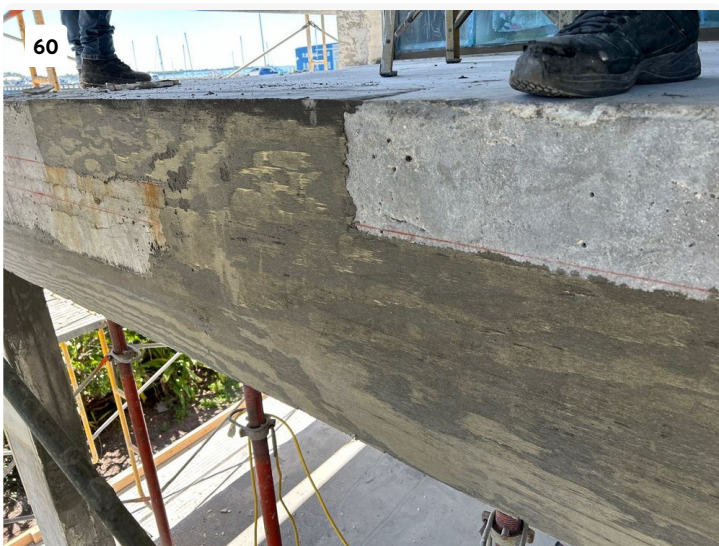
Balcony concrete repair.

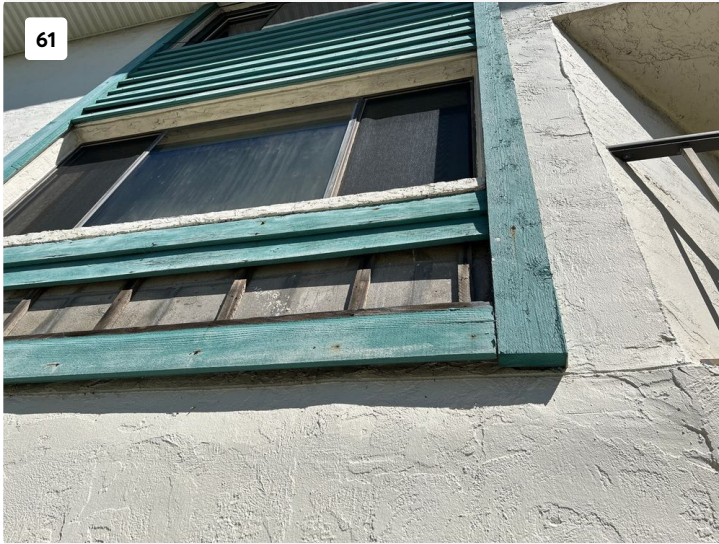
Damaged and rotting wood trim to be removed and replaced. Exposed CMU block underneath to be water-proofed.

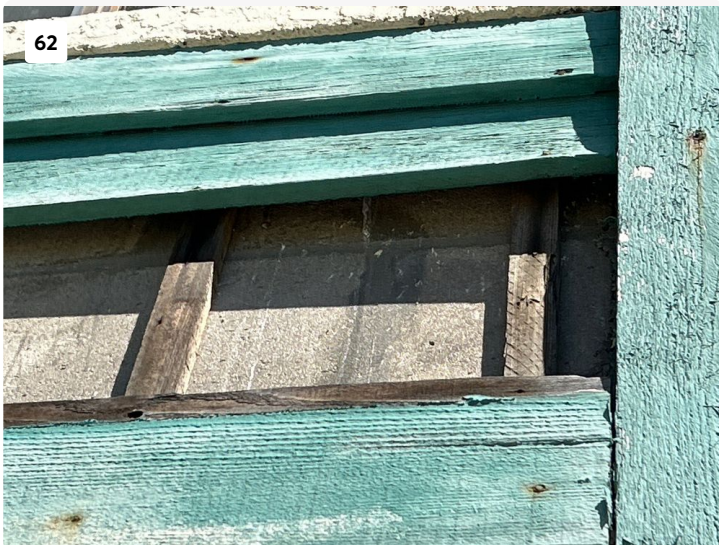
Damaged and rotting wood trim to be removed and replaced. Exposed CMU block underneath to be water-proofed.

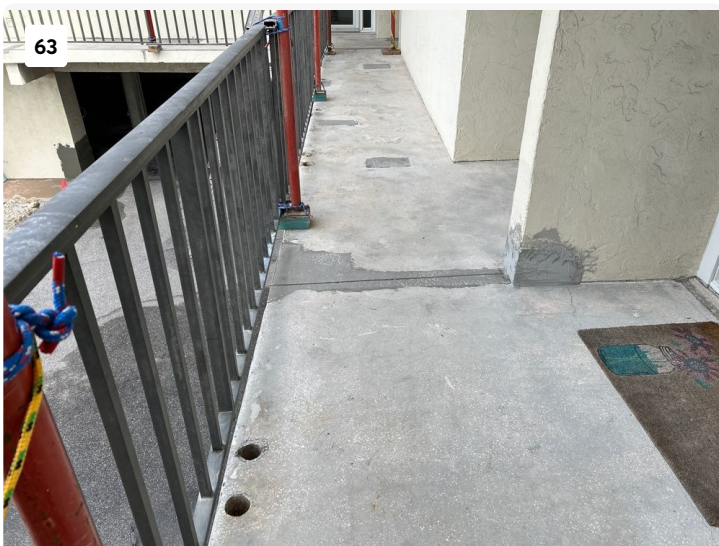
Joint created at location of walkway cracking.

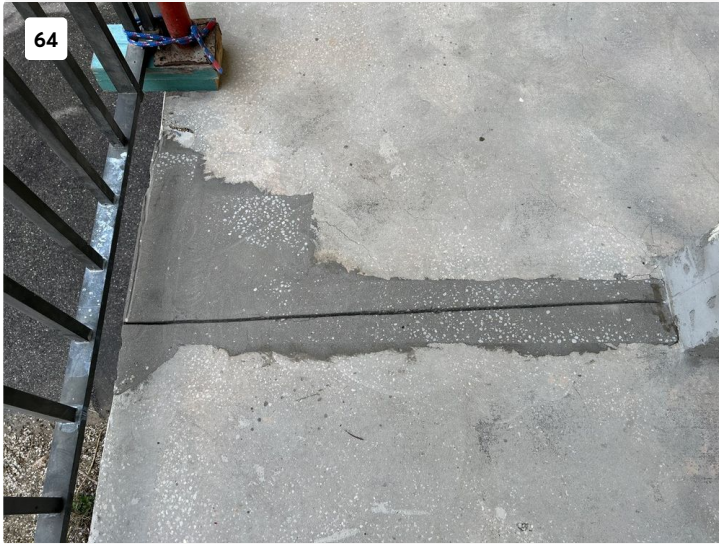
Joint created at location of walkway cracking.
