# MILESTONE INSPECTION REPORT FORMS - STRUCTURAL BSIP INSPECTION FORM

Form EB18 – 2024

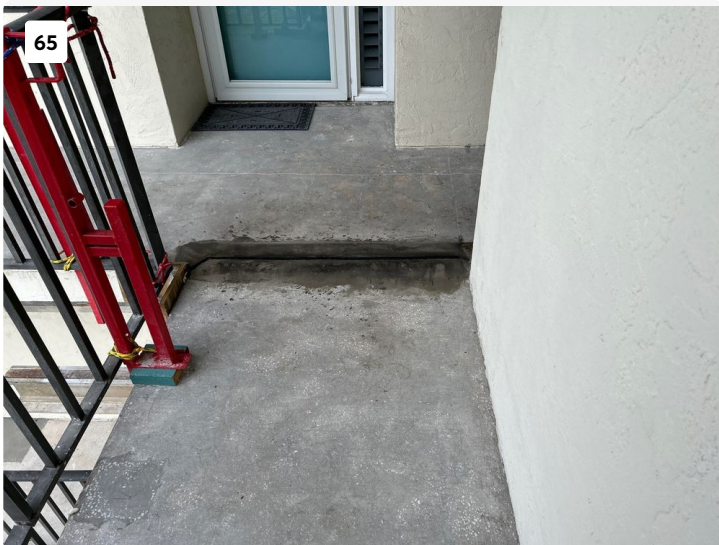
New walkway expansion joint.

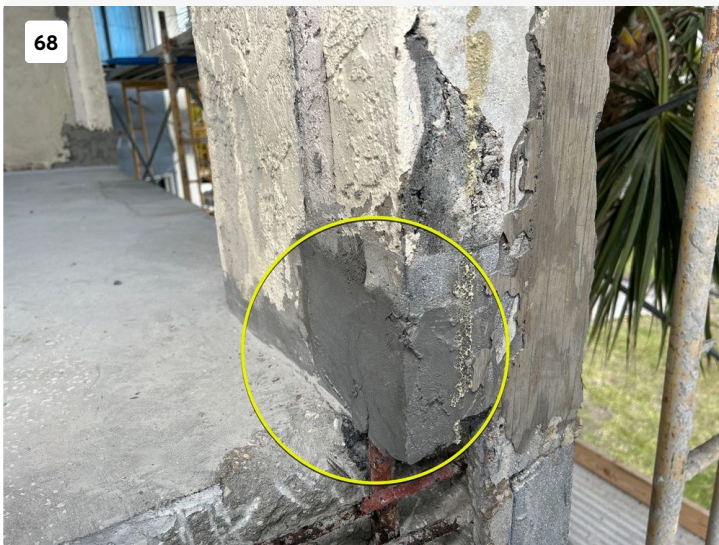
Failed previous concrete repair in balcony column.

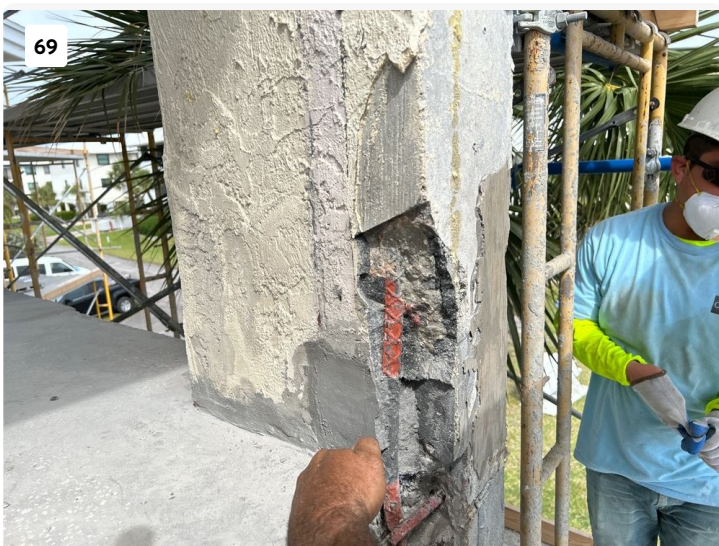
Failed previous concrete repair in balcony column.

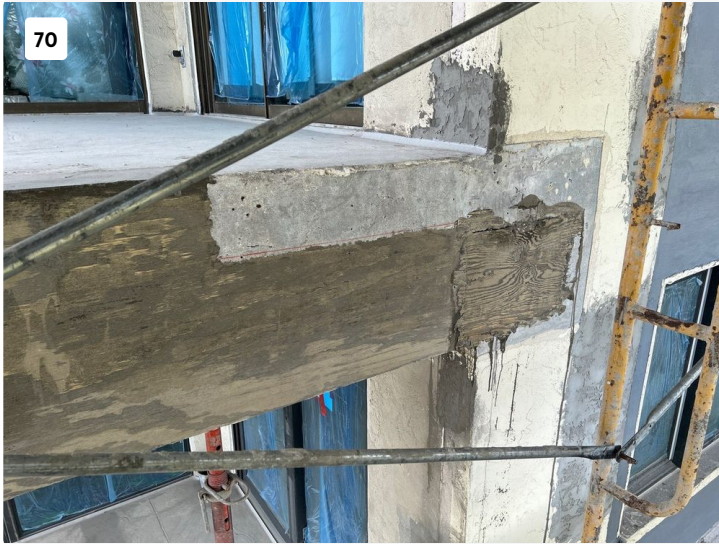
Completed balcony concrete repair.

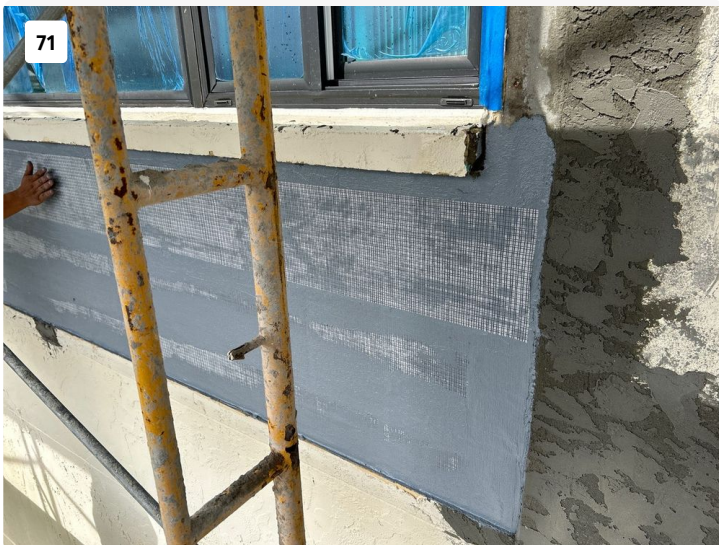
Waterproofing of CMU block in preparation for hardie trim.

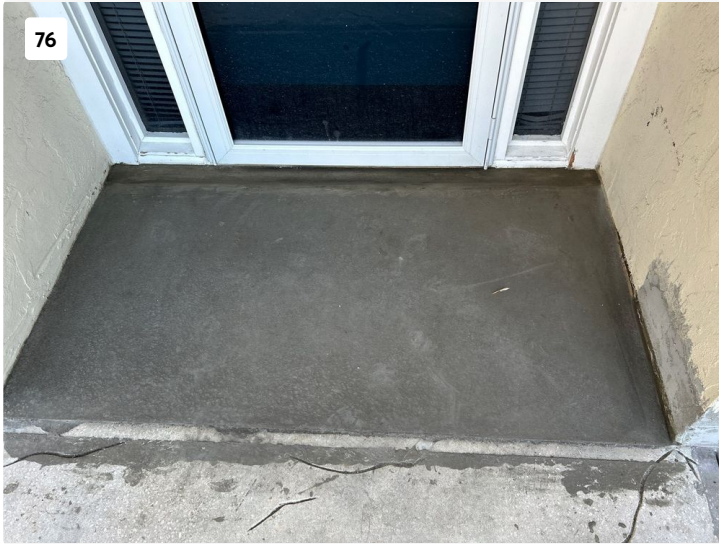
Front entry sloping and crack chasing in progress

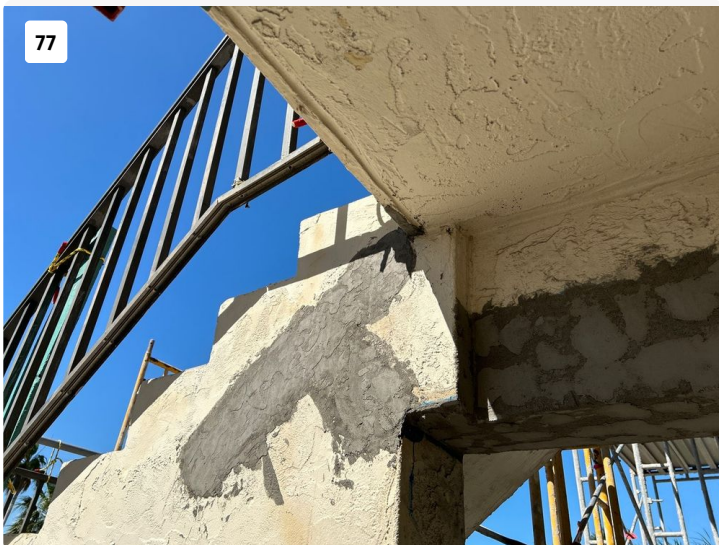
Stucco repair in texture phase.

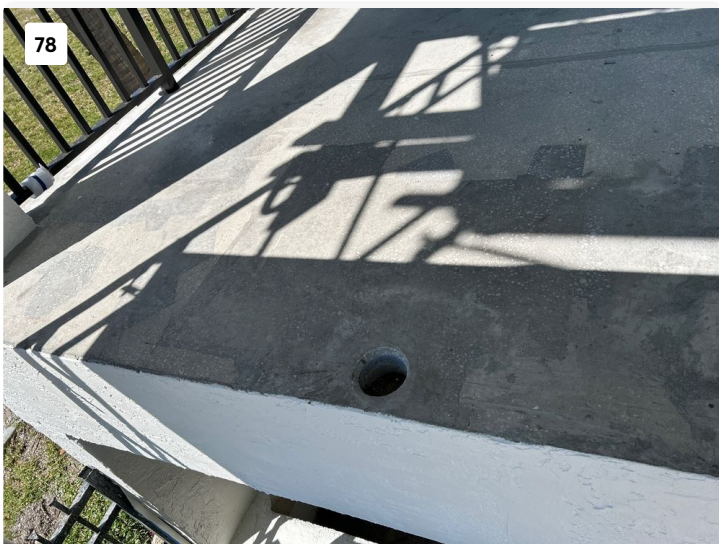
Project: Bridgeport  
Date: 4/12/2024, 10:54am  
Creator: Matthew Depin

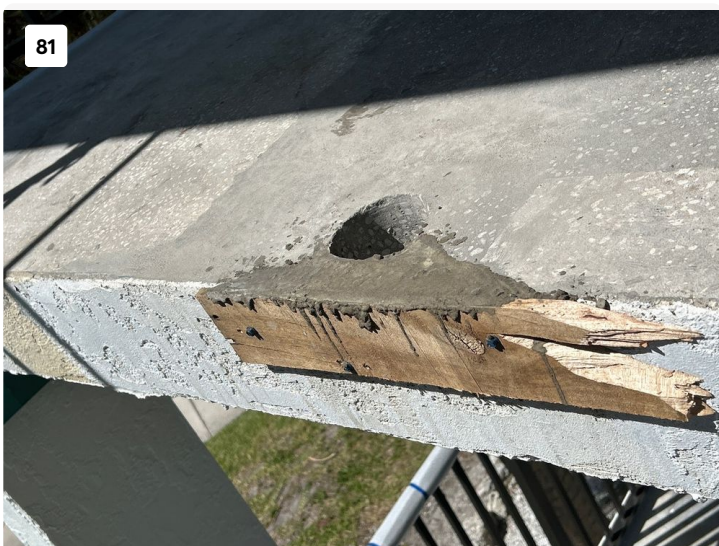
Project: Bridgeport  
Date: 4/12/2024, 11:28am  
Creator: Matthew Depin

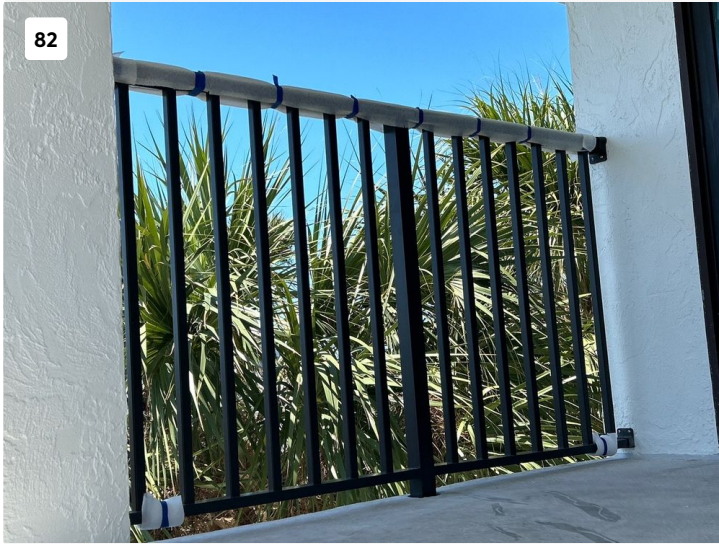
New balcony rail installation.

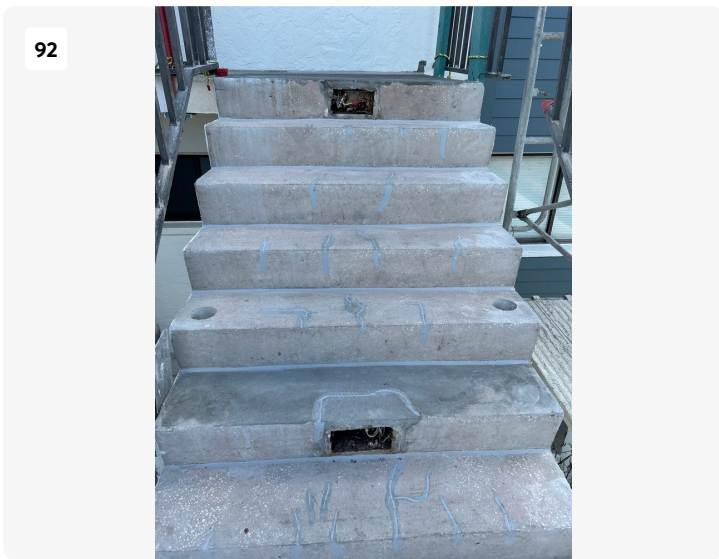
Stripped front stairs with completed crack chasing and sealants.

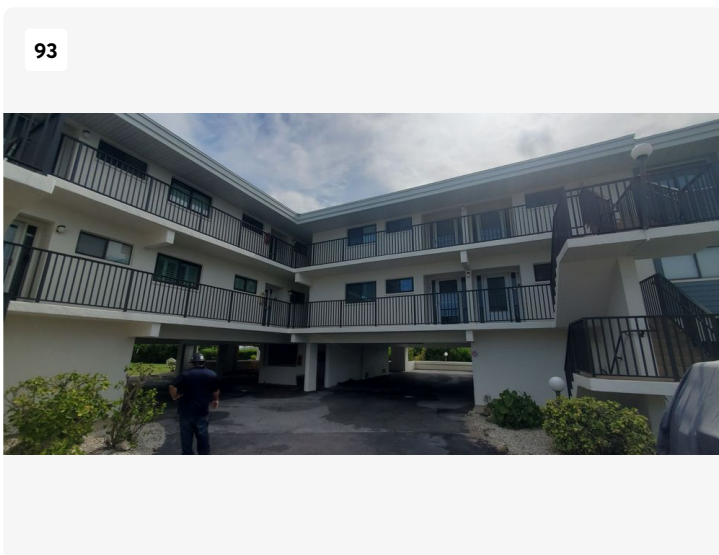
Exterior painting completed

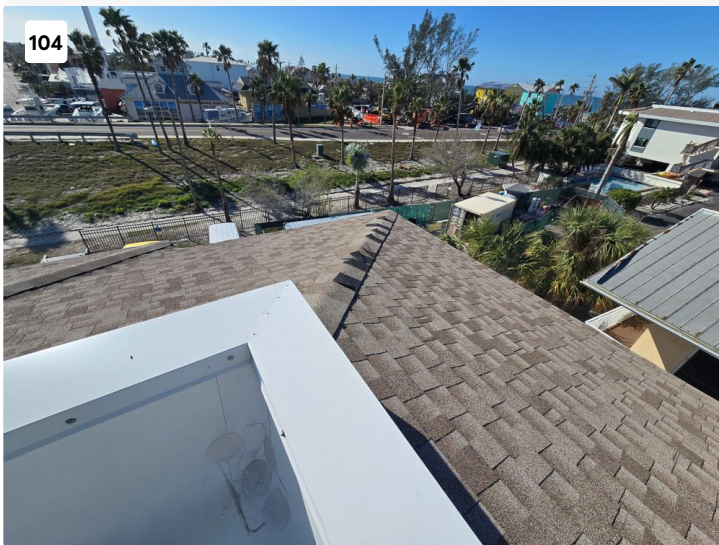
Shingles damaged during recent hurricane event.

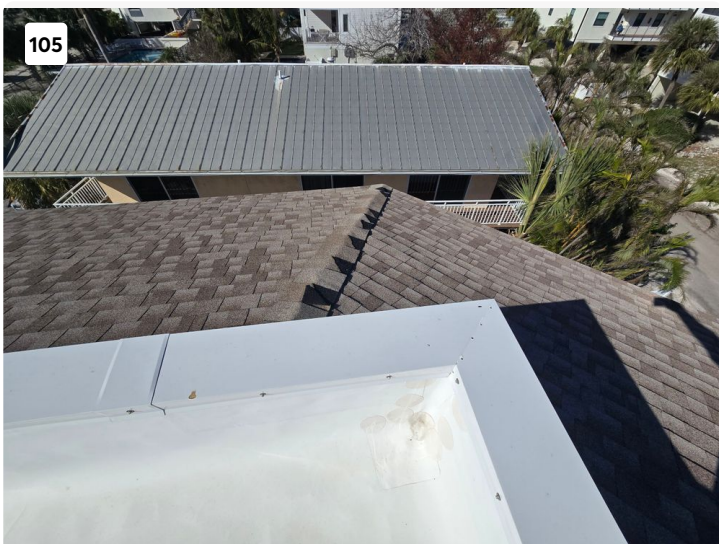
Shingles damaged during recent hurricane event.

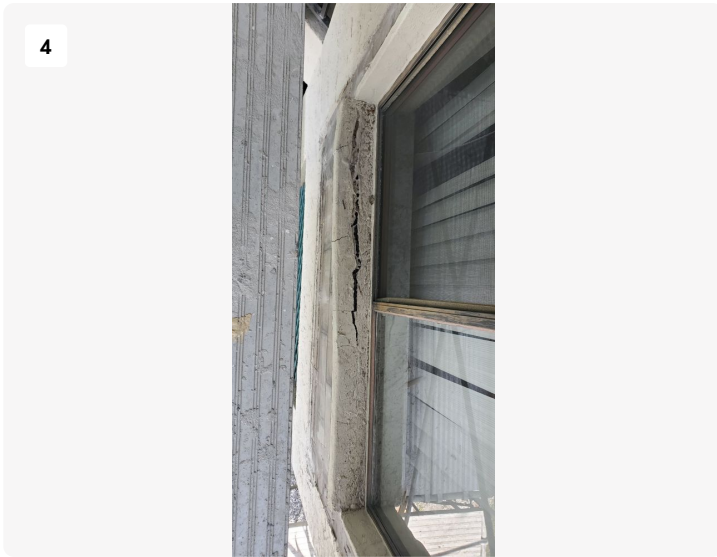
Spall in window sill.

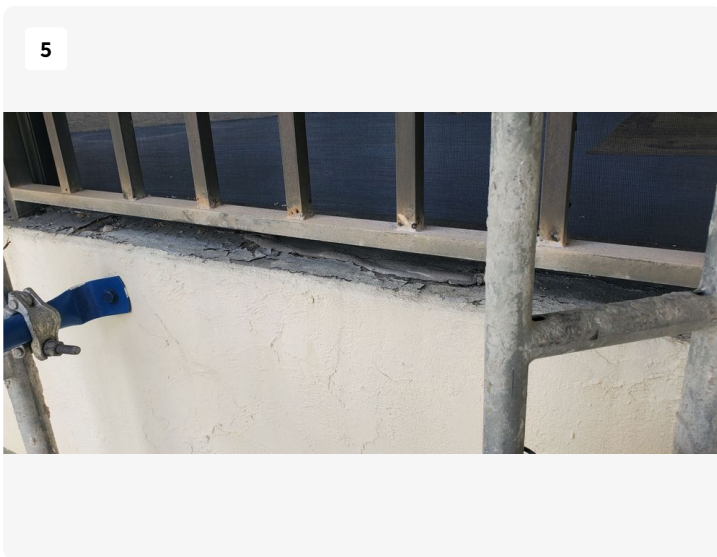
Cracking in balcony coating.

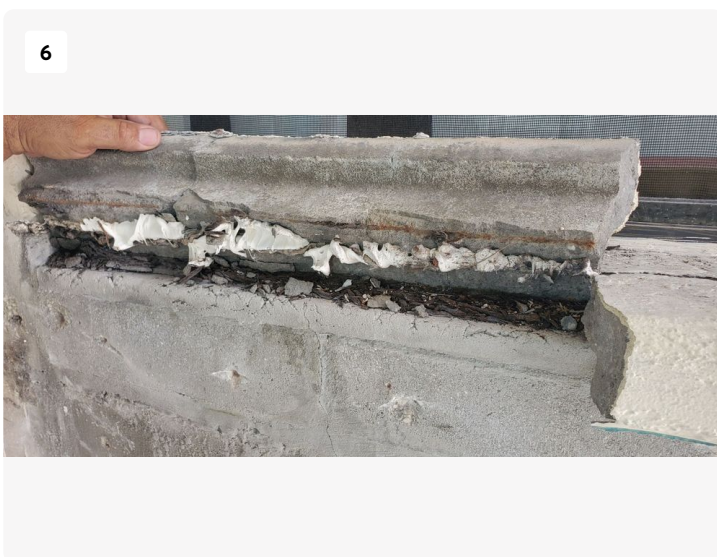
Spall in window sill evidencing previous repair.

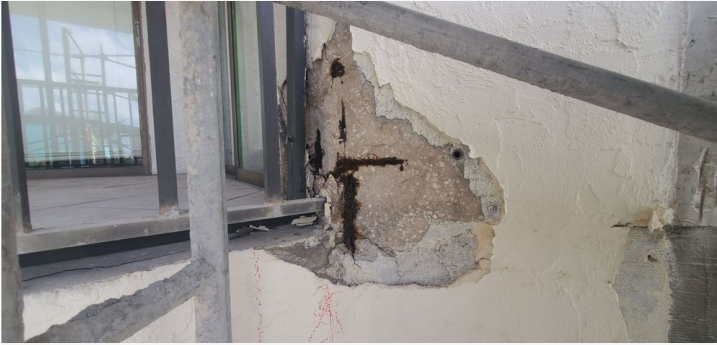
Project: Bridgeport  
Date: 5/20/2024, 11:20am  
Creator: Teddy Watkins

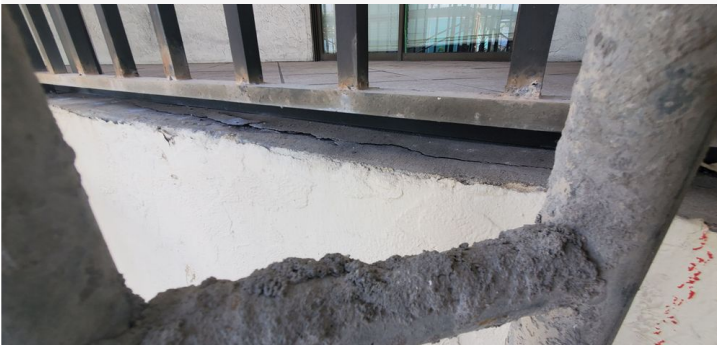
Project: Bridgeport  
Date: 5/20/2024, 11:22am  
Creator: Teddy Watkins

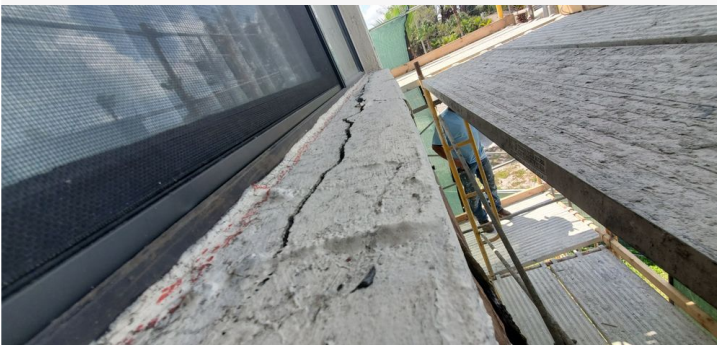
Project: Bridgeport  
Date: 5/20/2024, 11:28am  
Creator: Teddy Watkins

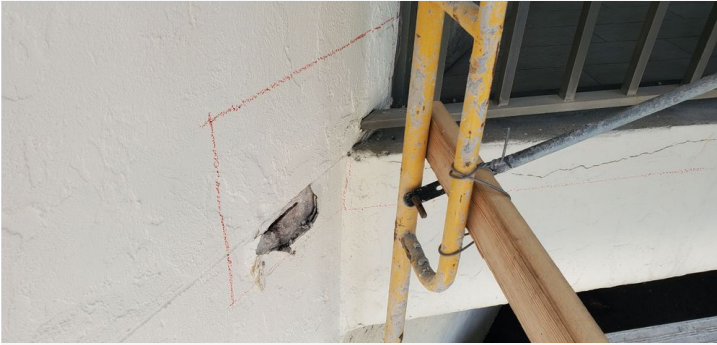
Project: Bridgeport  
Date: 5/20/2024, 11:30am  
Creator: Teddy Watkins

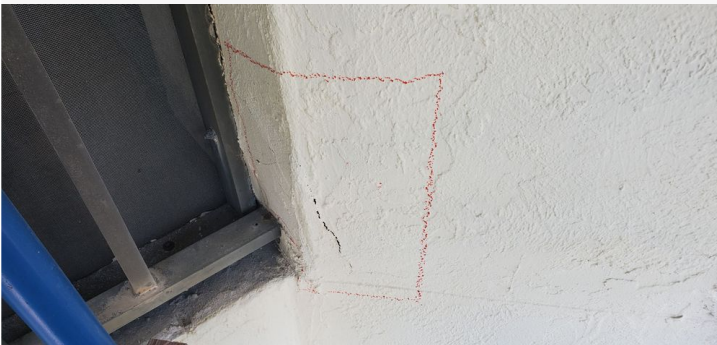
Project: Bridgeport  
Date: 5/20/2024, 11:56am  
Creator: Teddy Watkins

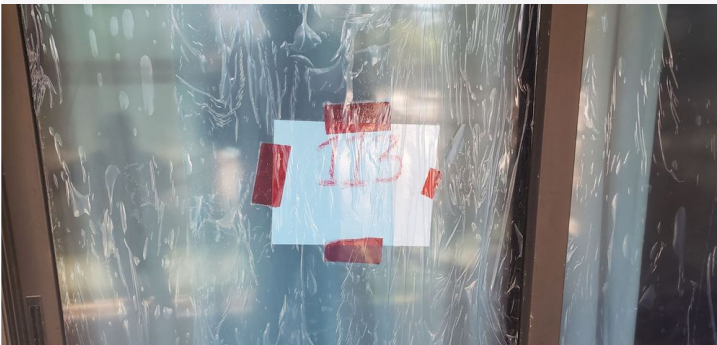
Project: Bridgeport  
Date: 5/23/2024, 11:56am  
Creator: Teddy Watkins

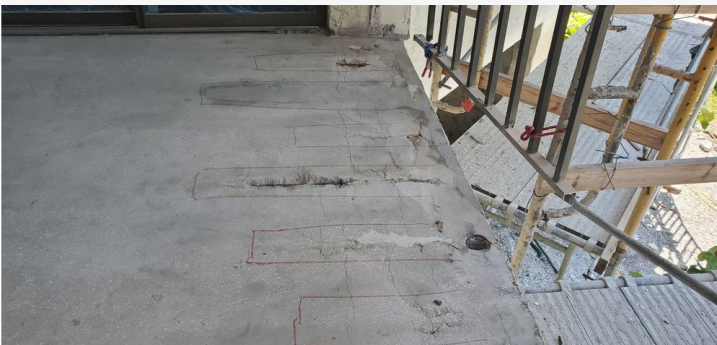
Project: Bridgeport  
Date: 5/23/2024, 11:56am  
Creator: Teddy Watkins

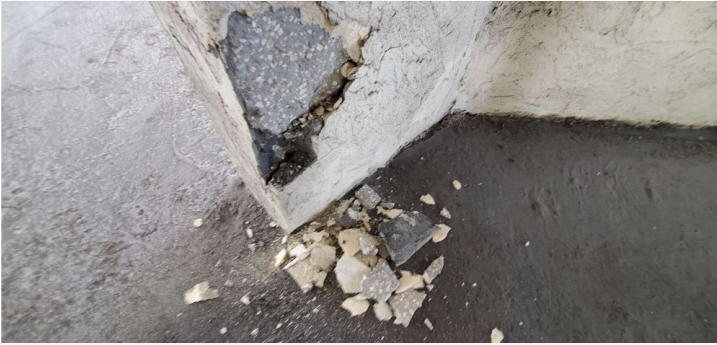
Project: Bridgeport  
Date: 5/23/2024, 12:32pm  
Creator: Teddy Watkins

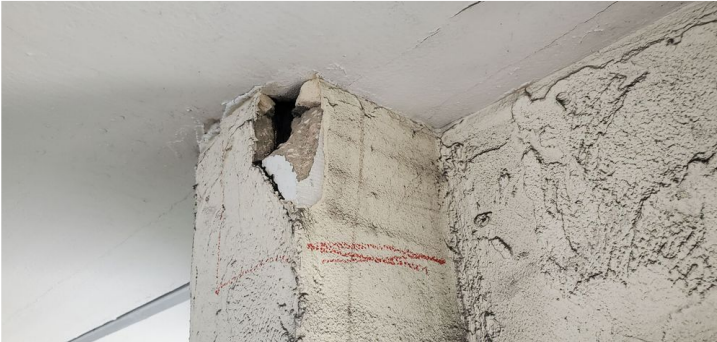
Project: Bridgeport  
Date: 5/23/2024, 12:43pm  
Creator: Teddy Watkins

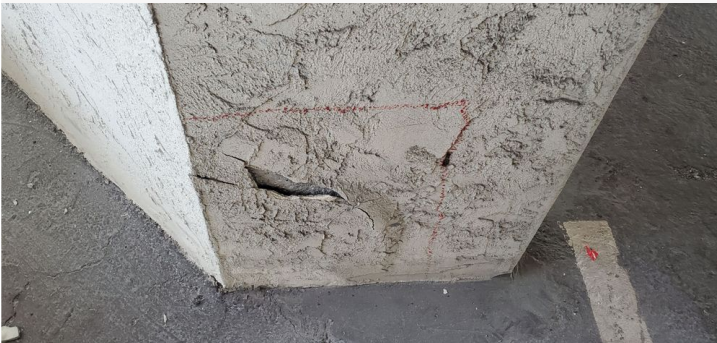
Project: Bridgeport  
Date: 5/23/2024, 12:43pm  
Creator: Teddy Watkins

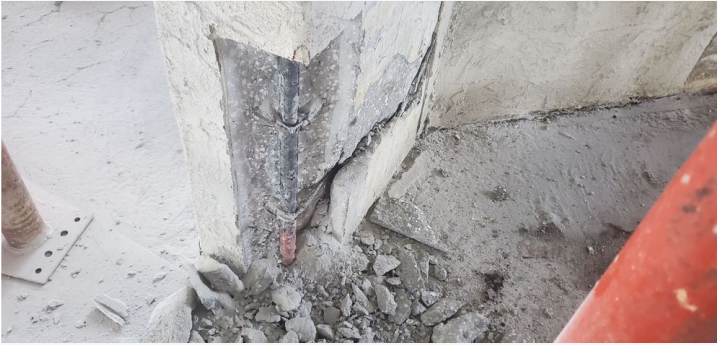
Project: Bridgeport  
Date: 5/28/2024, 10:30am  
Creator: Teddy Watkins

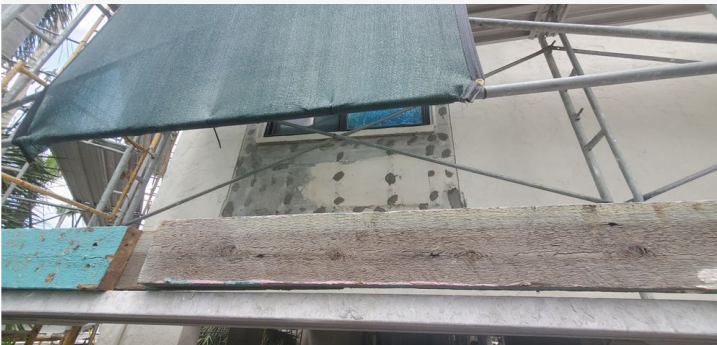
Project: Bridgeport  
Date: 5/28/2024, 10:35am  
Creator: Teddy Watkins

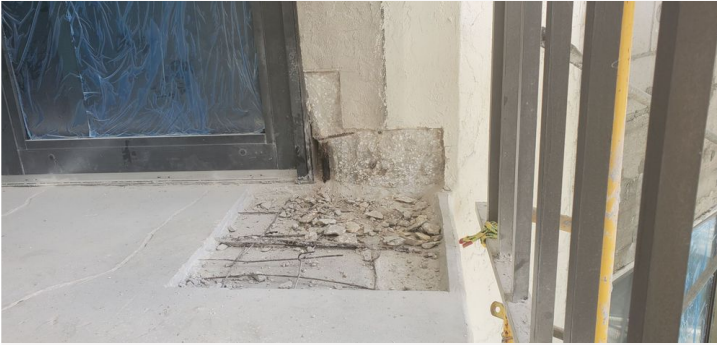
Project: Bridgeport  
Date: 5/28/2024, 10:44am  
Creator: Teddy Watkins

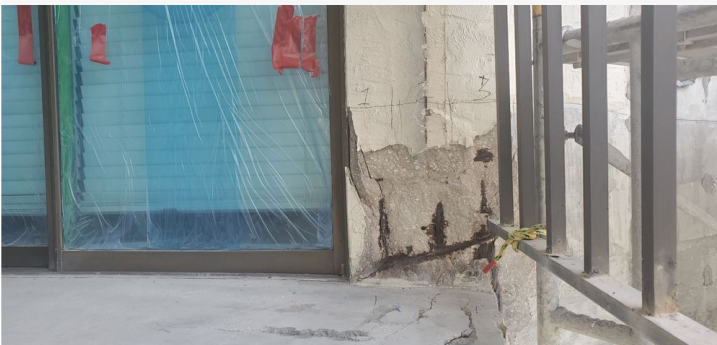
Project: Bridgeport  
Date: 5/28/2024, 11:14am  
Creator: Teddy Watkins

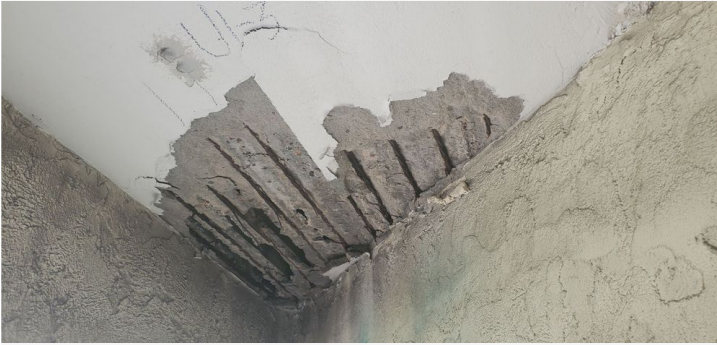
Project: Bridgeport  
Date: 5/28/2024, 11:46am  
Creator: Teddy Watkins

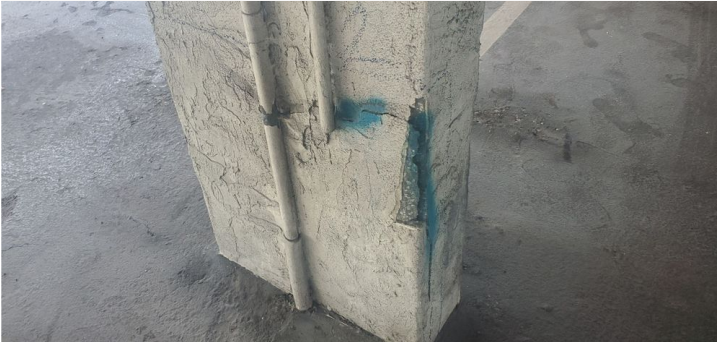
Project: Bridgeport  
Date: 5/28/2024, 12:11pm  
Creator: Teddy Watkins

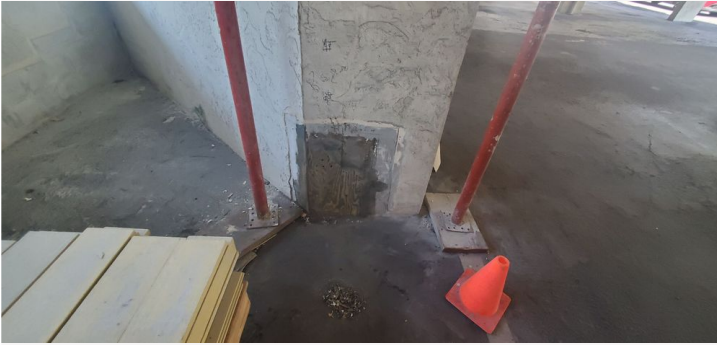
Project: Bridgeport  
Date: 5/31/2024, 10:13am  
Creator: Teddy Watkins

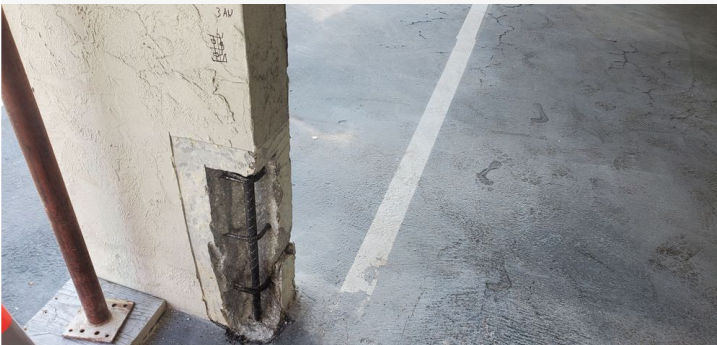
Project: Bridgeport  
Date: 5/31/2024, 10:23am  
Creator: Teddy Watkins

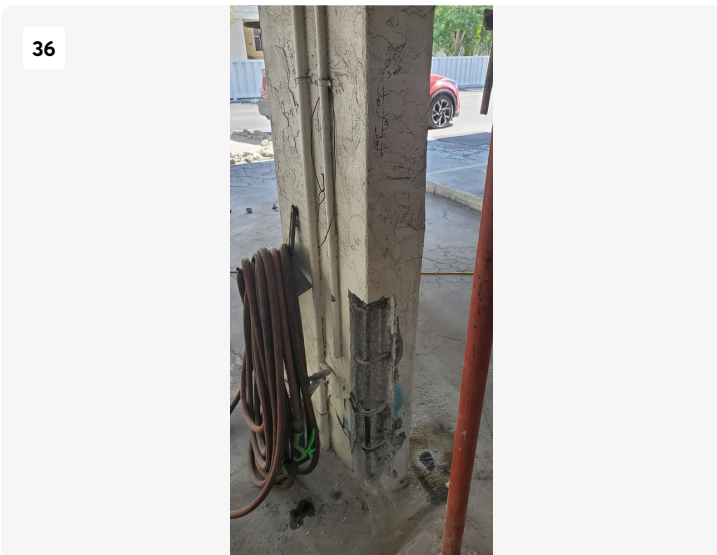
Project: Bridgeport  
Date: 5/31/2024, 10:32am  
Creator: Teddy Watkins

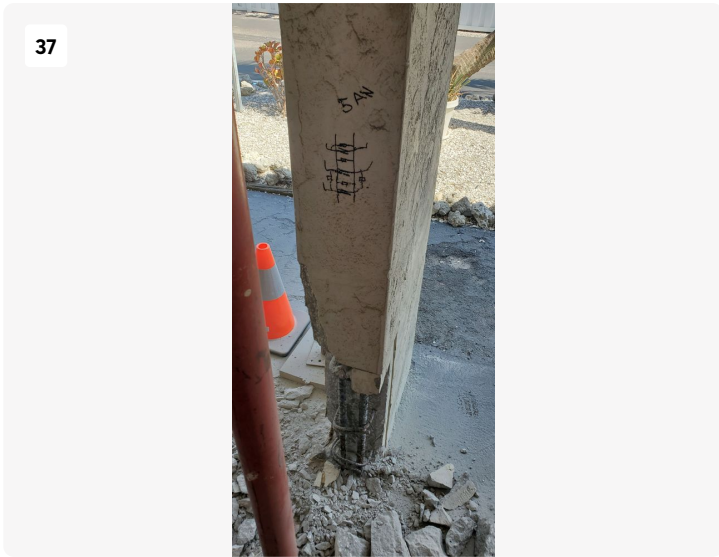
Garage column concrete repair in progress.

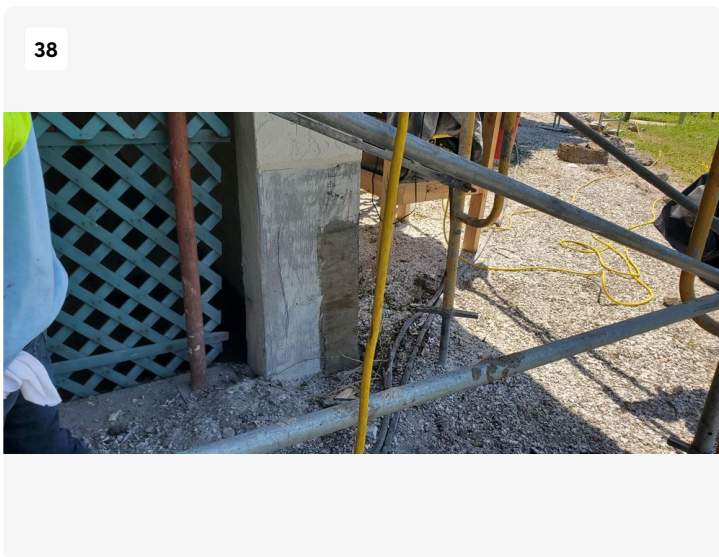
Garage exterior column concrete repair in progress.

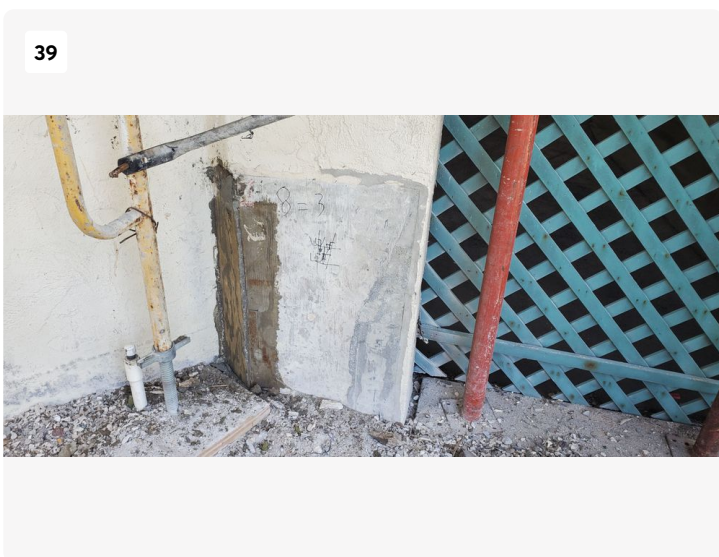
Garage exterior column concrete repair in progress.

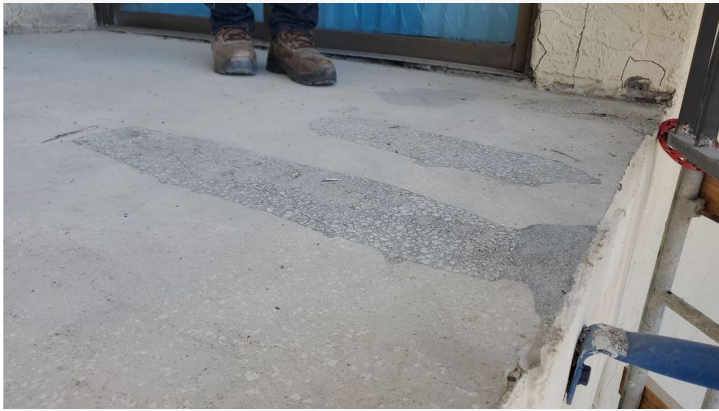
Previous repairs of balcony topping slab.

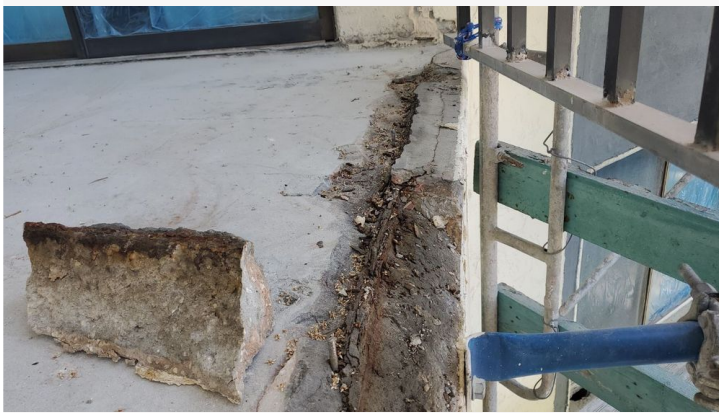
Balcony slab edge spall.

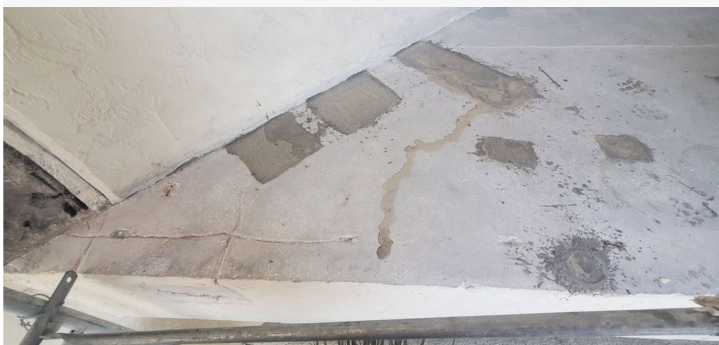
Completed topping slab repairs. Crack chasing in progress.

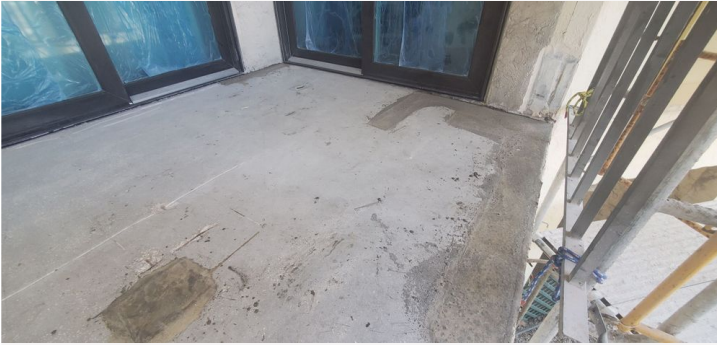
Project: Bridgeport  
Date: 6/6/2024, 10:22am  
Creator: Teddy Watkins

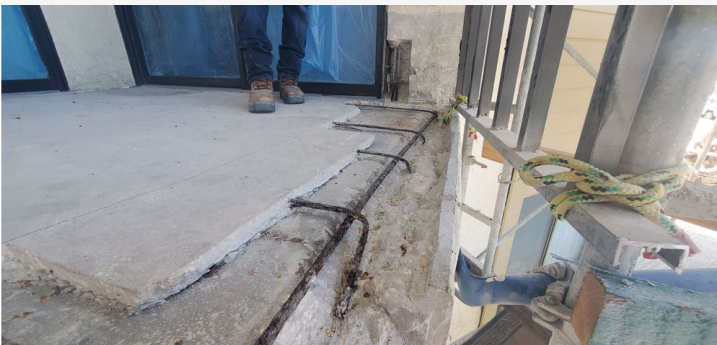
Project: Bridgeport  
Date: 6/6/2024, 10:36am  
Creator: Teddy Watkins

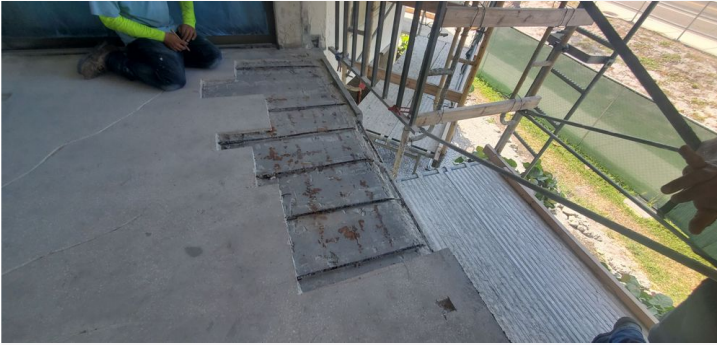
Project: Bridgeport  
Date: 6/6/2024, 10:57am  
Creator: Teddy Watkins

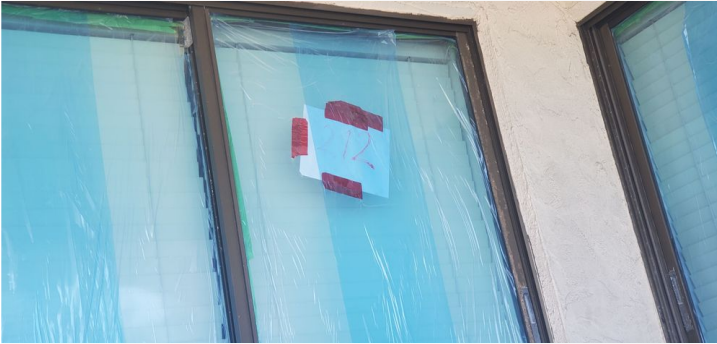
Project: Bridgeport  
Date: 6/6/2024, 11:07am  
Creator: Teddy Watkins

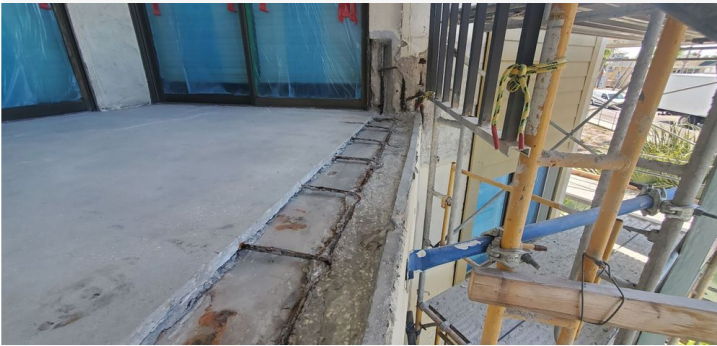
Project: Bridgeport  
Date: 6/6/2024, 11:07am  
Creator: Teddy Watkins

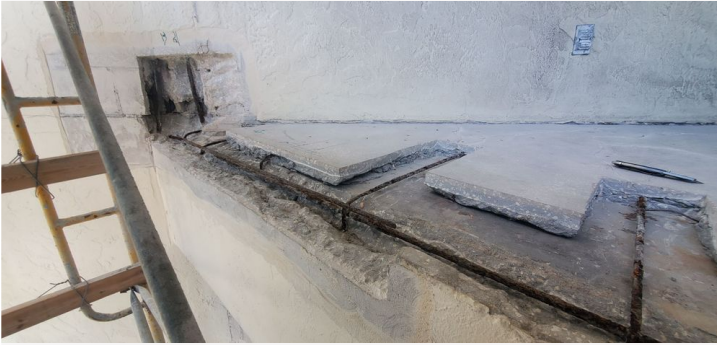
Project: Bridgeport  
Date: 6/6/2024, 11:19am  
Creator: Teddy Watkins

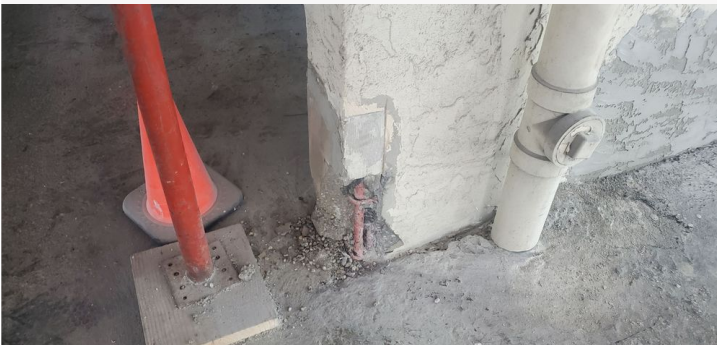
Garage column spall repair in progress. Evidence of previous repair.

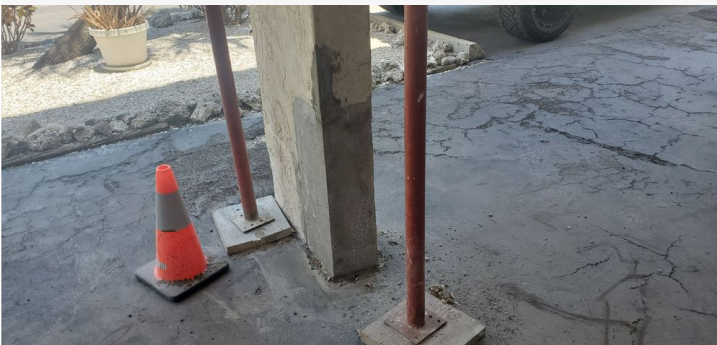
Garage column repair completed and awaiting stucco application.

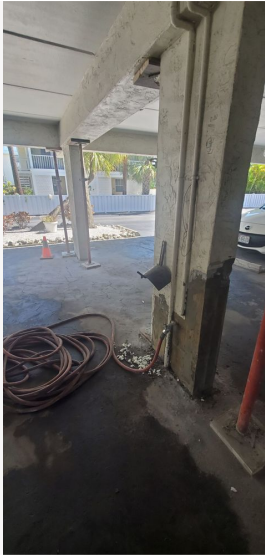
Garage column repair completed and awaiting stucco application.

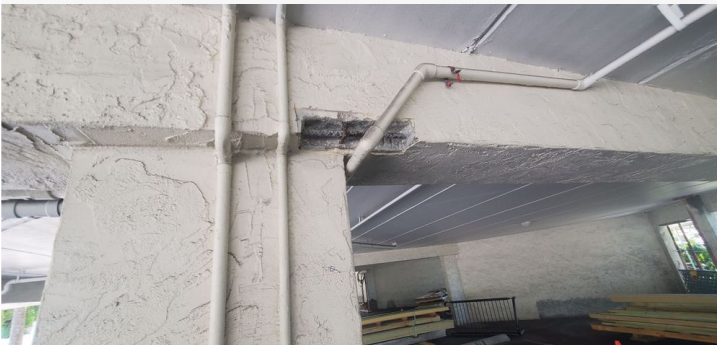
Garage beam spall repair.

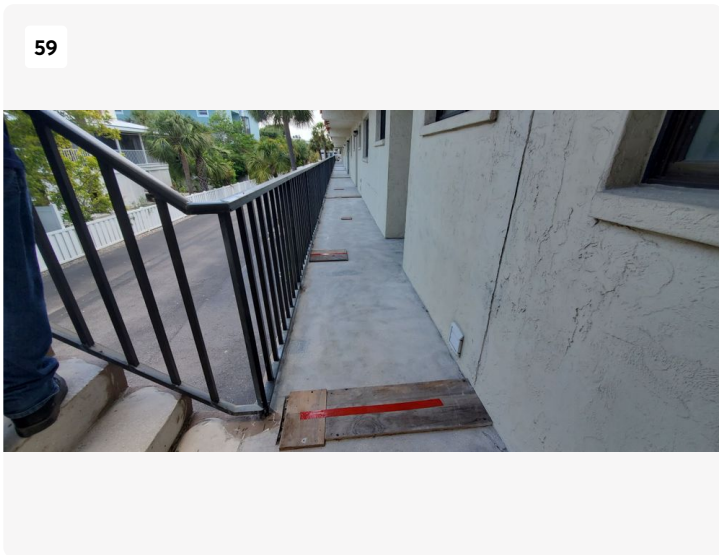
Walkway stripped and repairs in progress.

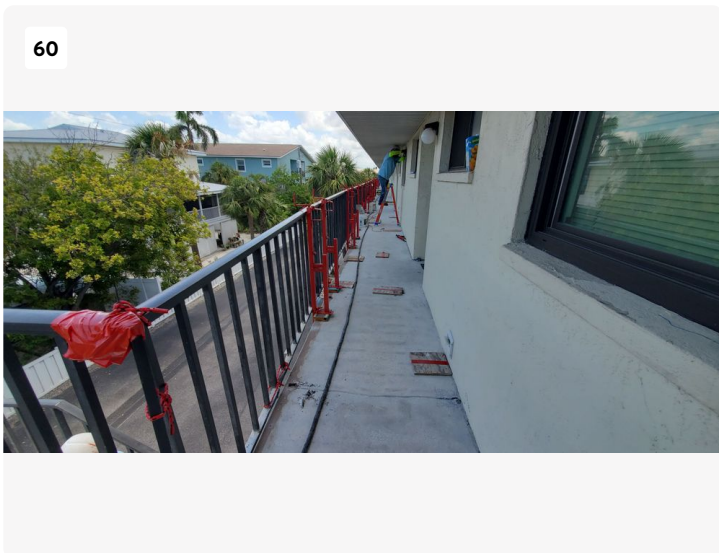
Walkway stripped and repairs in progress.

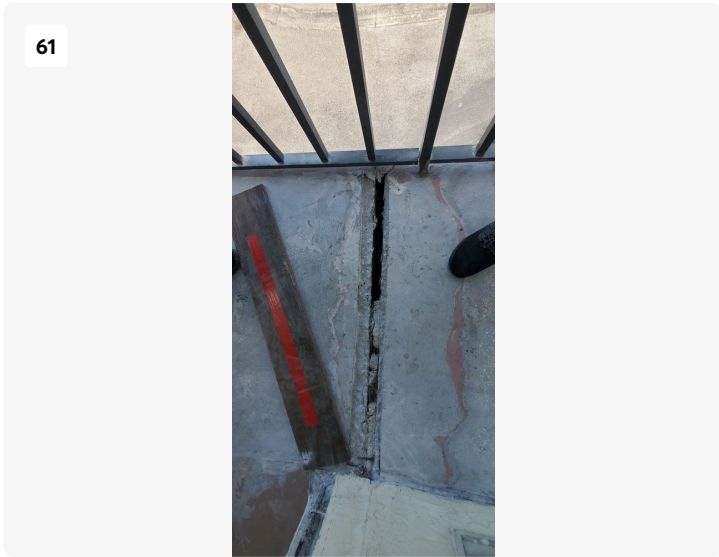
Control joint between hollow cores.

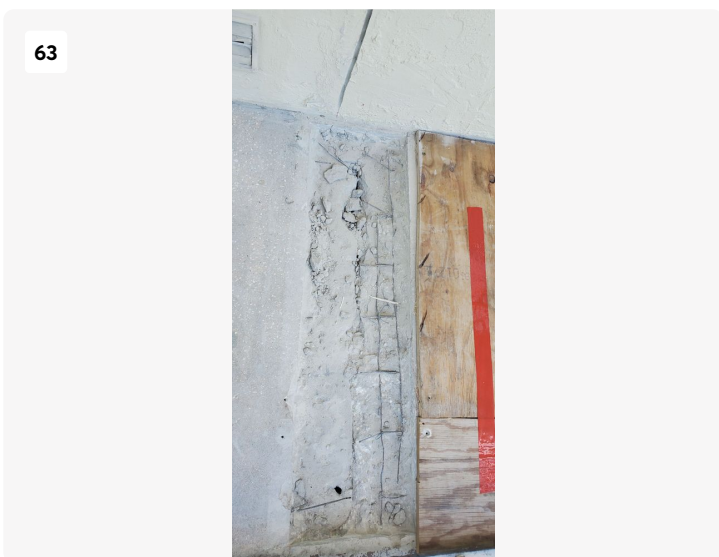
Walkway spall repair.

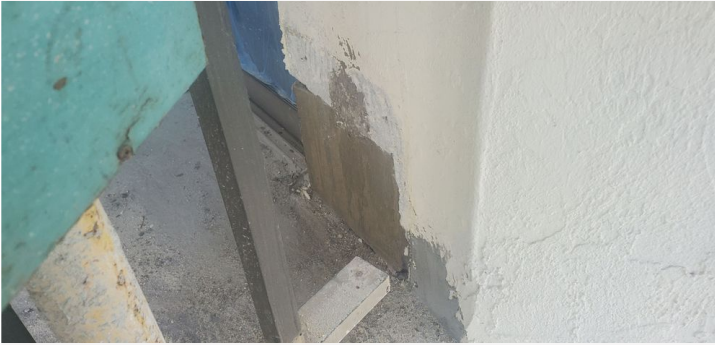
Project: Bridgeport  
Date: 6/27/2024, 11:40am  
Creator: Teddy Watkins

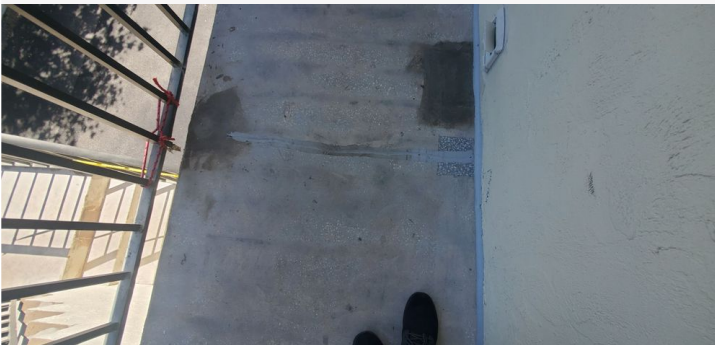
Project: Bridgeport  
Date: 7/3/2024, 10:58am  
Creator: Teddy Watkins

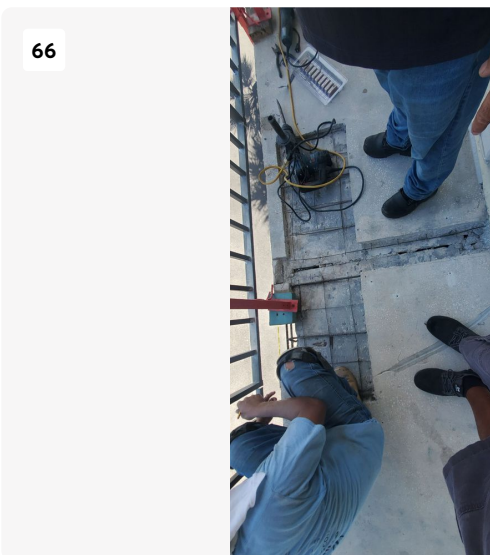
Project: Bridgeport  
Date: 7/3/2024, 10:58am  
Creator: Teddy Watkins

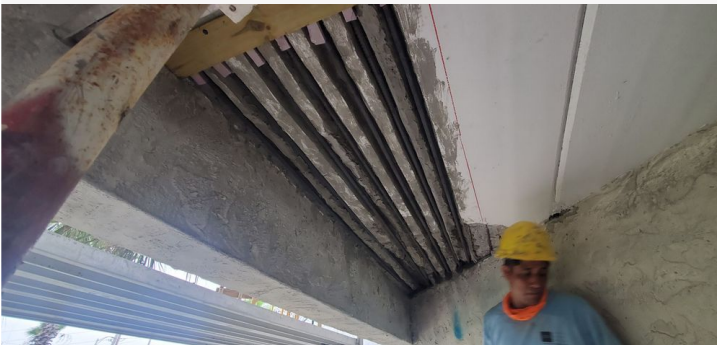
Project: Bridgeport  
Date: 7/11/2024, 10:23am  
Creator: Teddy Watkins

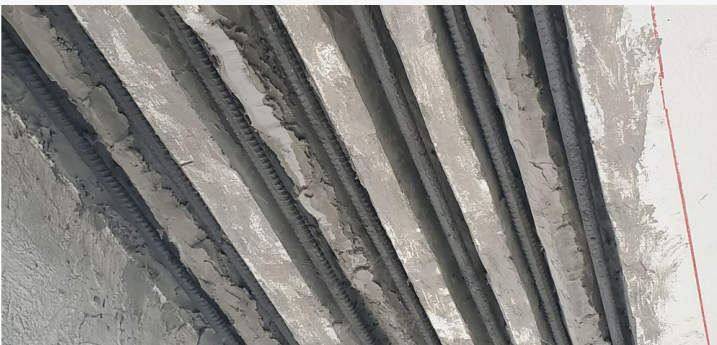
Project: Bridgeport  
Date: 7/11/2024, 10:23am  
Creator: Teddy Watkins

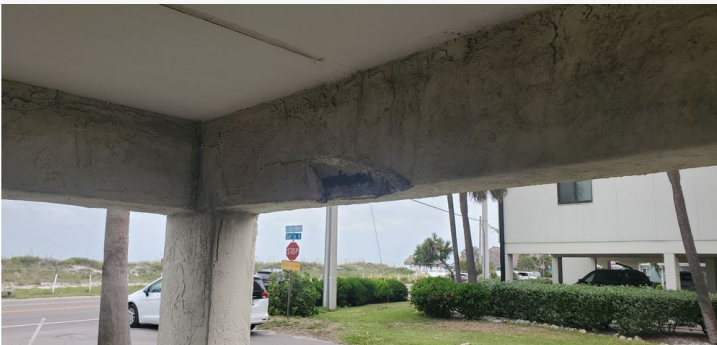
Project: Bridgeport  
Date: 7/11/2024, 10:53am  
Creator: Teddy Watkins

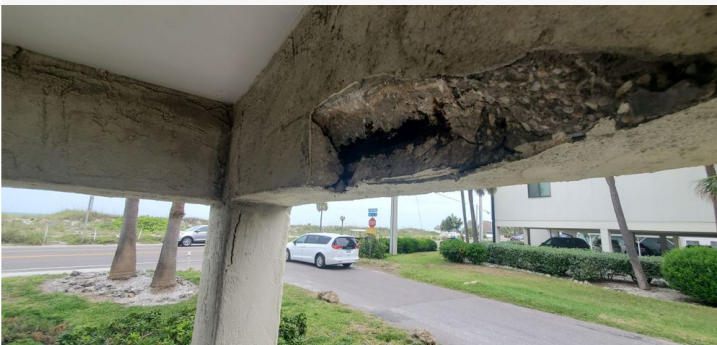
Project: Bridgeport  
Date: 7/11/2024, 10:53am  
Creator: Teddy Watkins

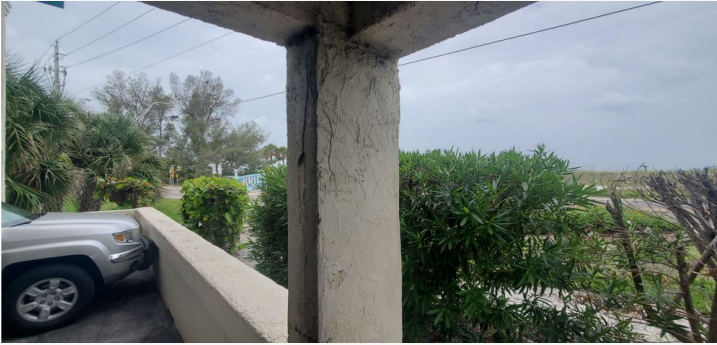
Project: Bridgeport  
Date: 7/11/2024, 10:54am  
Creator: Teddy Watkins

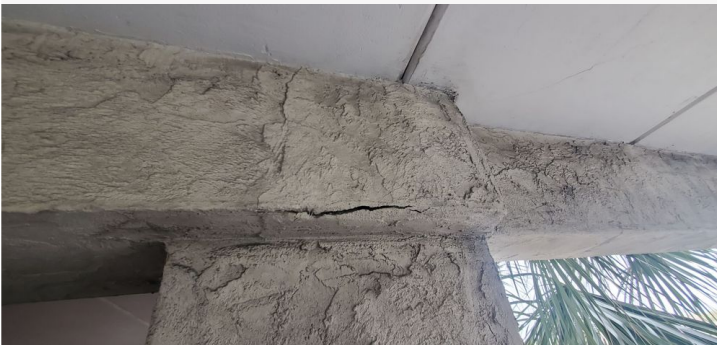
Project: Bridgeport  
Date: 7/11/2024, 10:56am  
Creator: Teddy Watkins

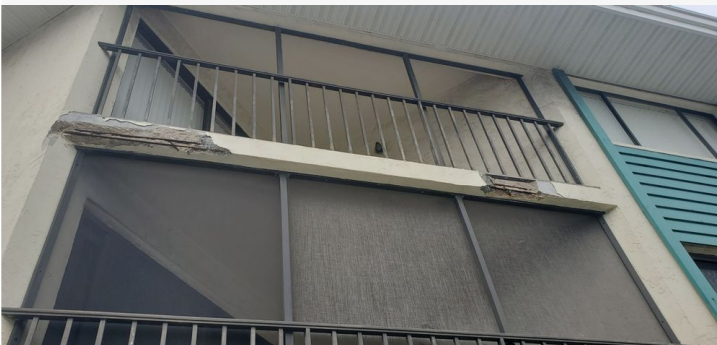
Project: Bridgeport  
Date: 7/11/2024, 10:58am  
Creator: Teddy Watkins

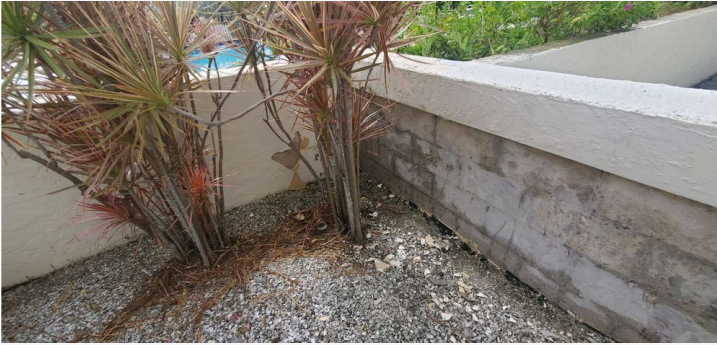
Project: Bridgeport  
Date: 7/25/2024, 10:39am  
Creator: Teddy Watkins

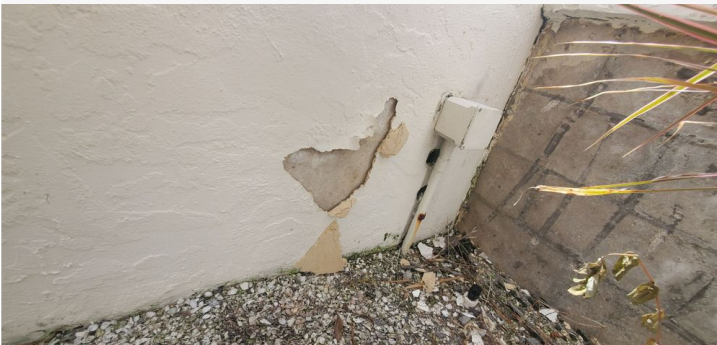
Project: Bridgeport  
Date: 7/25/2024, 10:40am  
Creator: Teddy Watkins

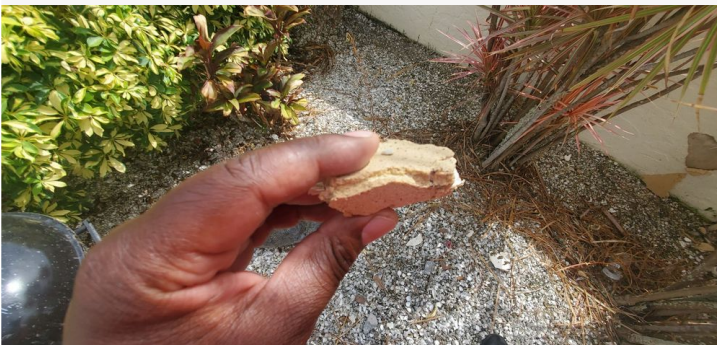
Project: Bridgeport  
Date: 7/25/2024, 10:40am  
Creator: Teddy Watkins

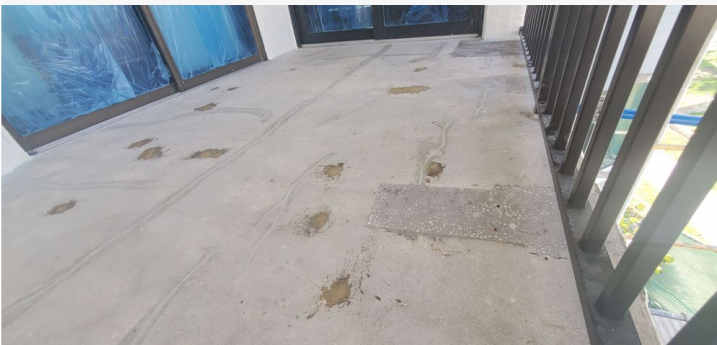
Project: Bridgeport  
Date: 7/31/2024, 10:19am  
Creator: Teddy Watkins

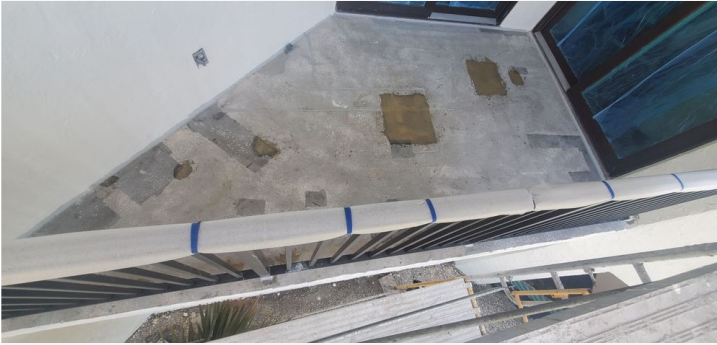
Project: Bridgeport  
Date: 7/31/2024, 10:19am  
Creator: Teddy Watkins

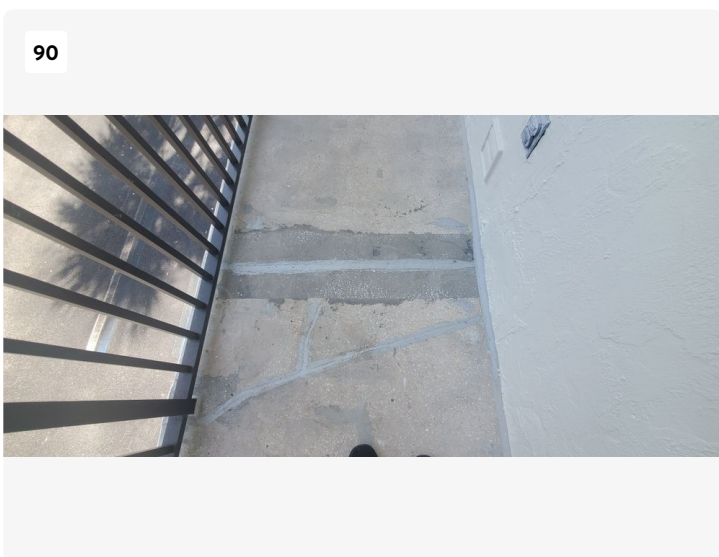
Project: Bridgeport  
Date: 7/31/2024, 10:24am  
Creator: Teddy Watkins
