# MILESTONE INSPECTION REPORT FORMS - STRUCTURAL BSIP INSPECTION FORM

Form EB18 – 2024

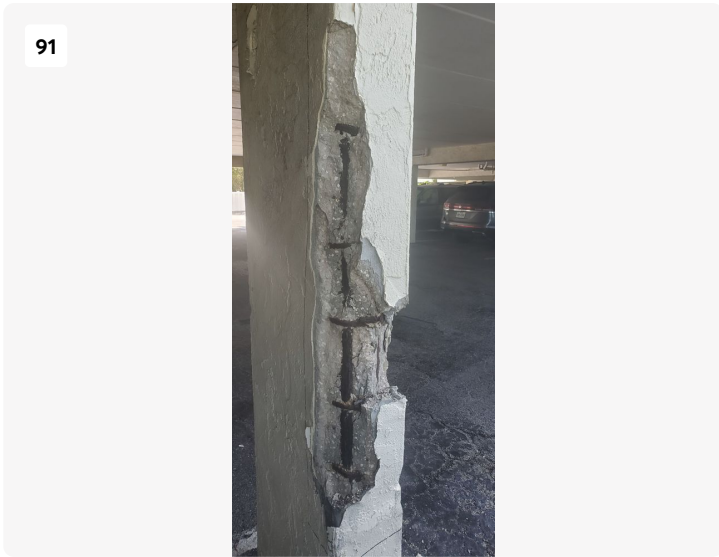
Garage column spall demo in progress.

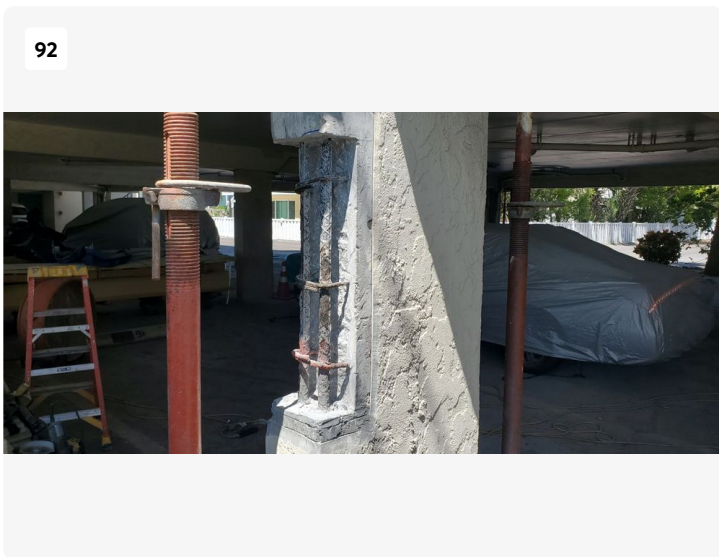
Garage column spall repair in progress.

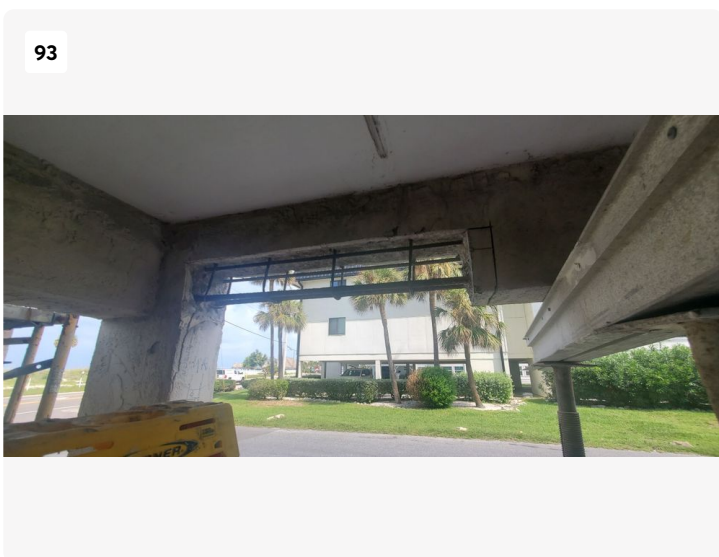
Beam repair in progress.

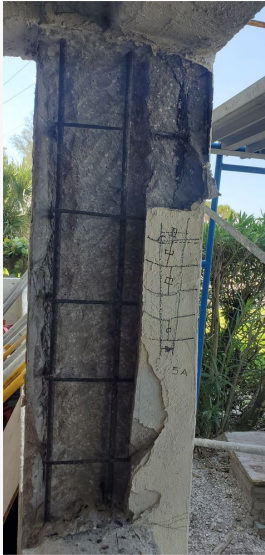
Garage column spall demo in progress.

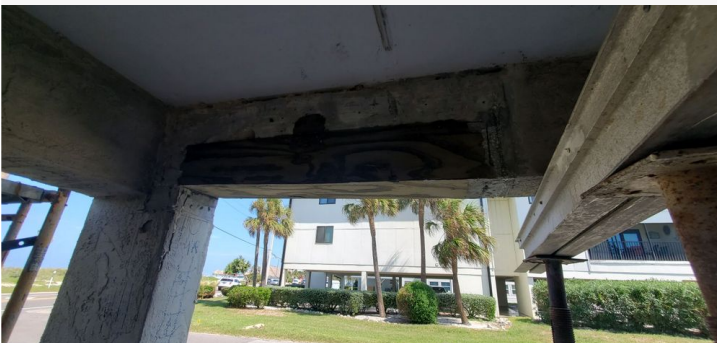
Beam repair completed.

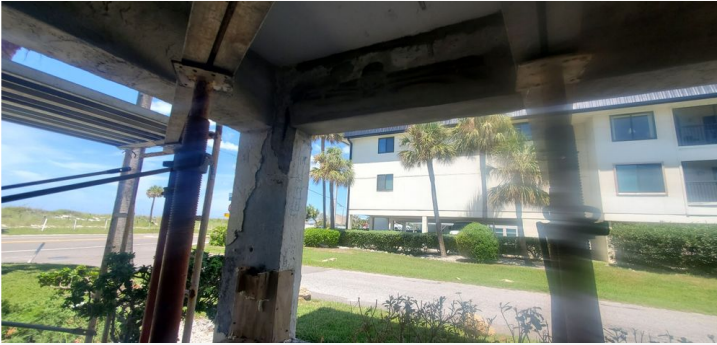
Project: Bridgeport  
Date: 8/27/2024, 1:11pm  
Creator: Teddy Watkins

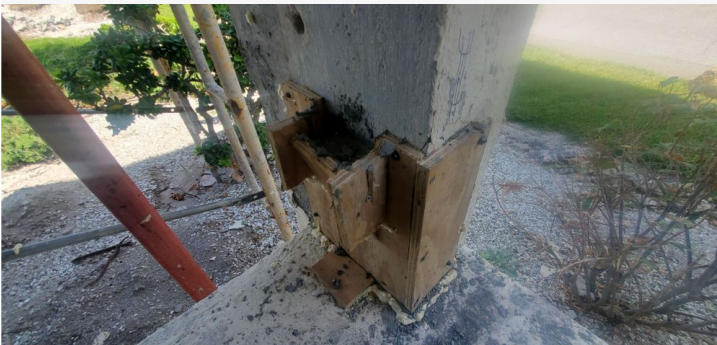
Project: Bridgeport  
Date: 8/27/2024, 1:11pm  
Creator: Teddy Watkins

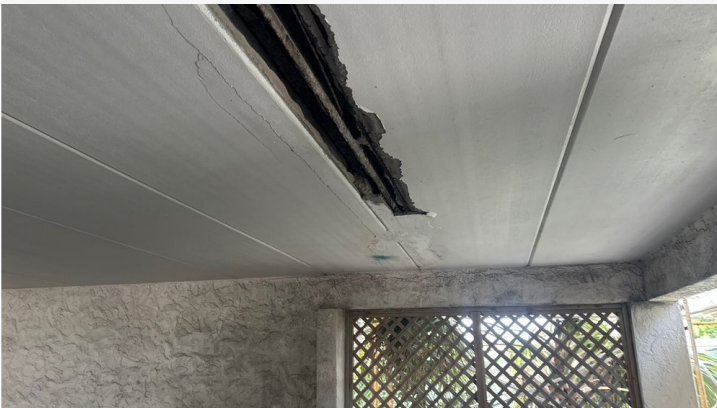
Project: Bridgeport  
Date: 9/4/2024, 12:29pm  
Creator: Clayton Prescott

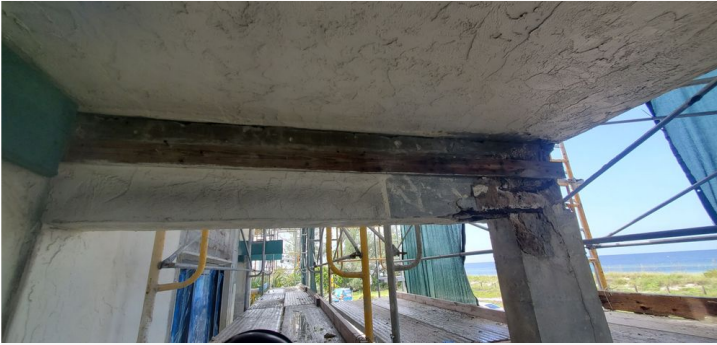
Project: Bridgeport  
Date: 9/5/2024, 11:54am  
Creator: Teddy Watkins

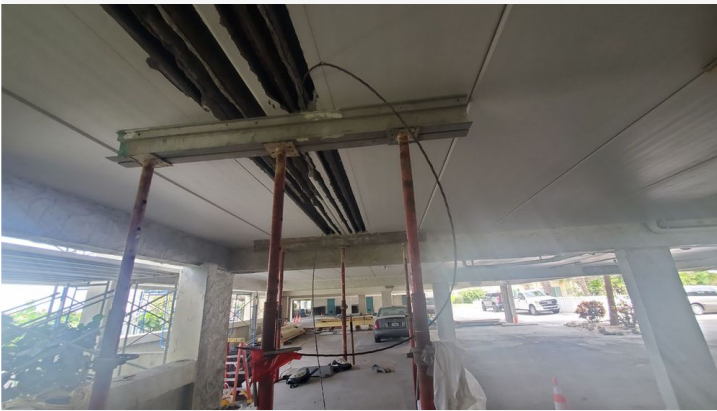
Project: Bridgeport  
Date: 9/10/2024, 12:35pm  
Creator: Teddy Watkins

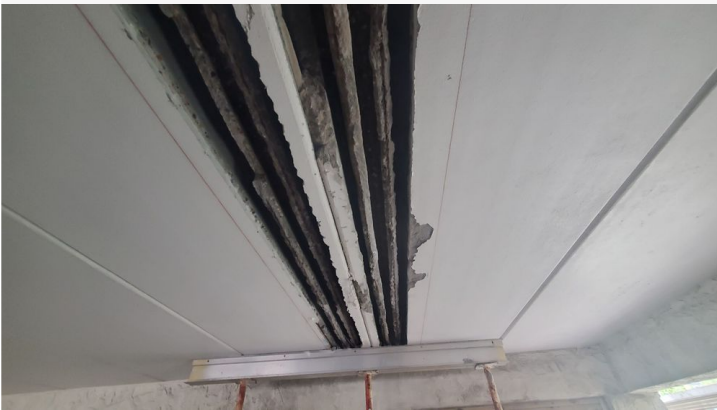
Project: Bridgeport  
Date: 9/10/2024, 12:35pm  
Creator: Teddy Watkins

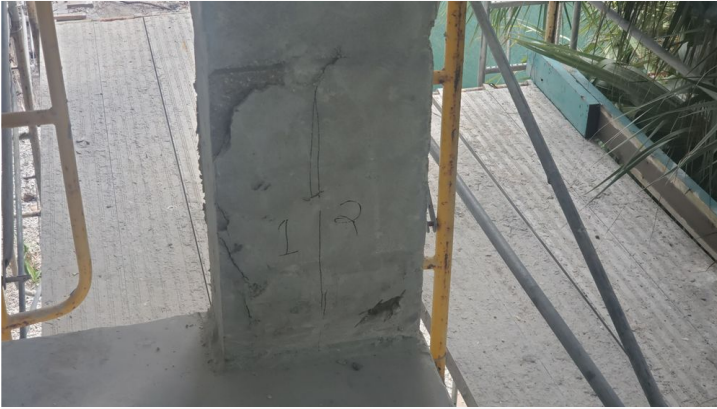
Balcony column spall.

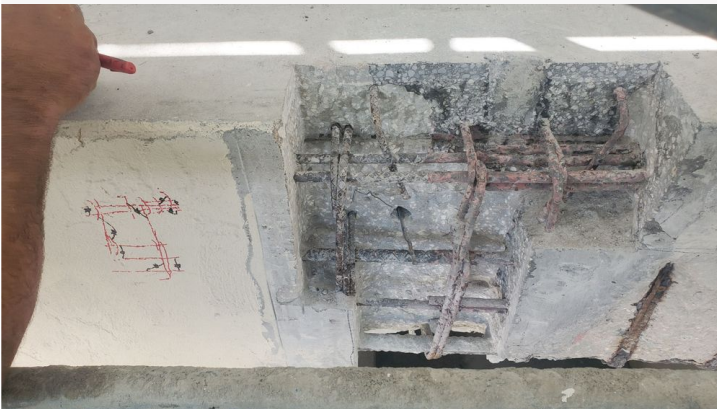
Balcony beam repair in progress.

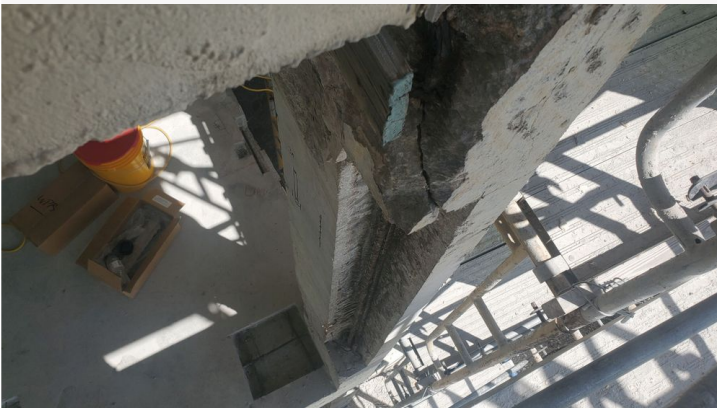
Balcony column repair in progress.

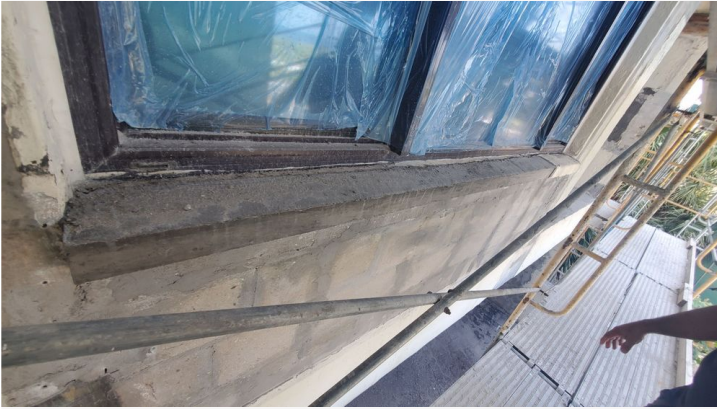
Repaired window sill.

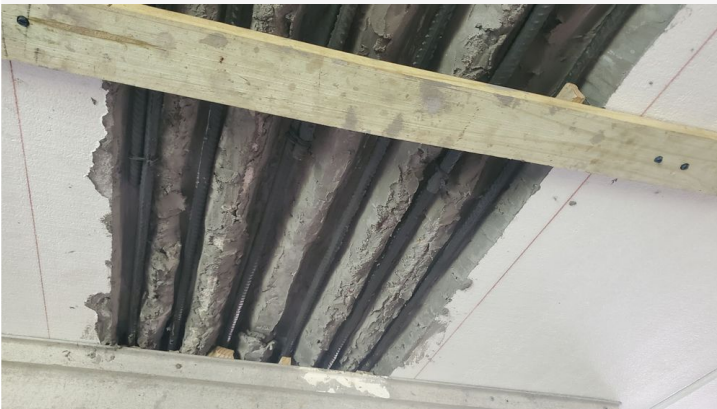
Hollow core repair in progress.

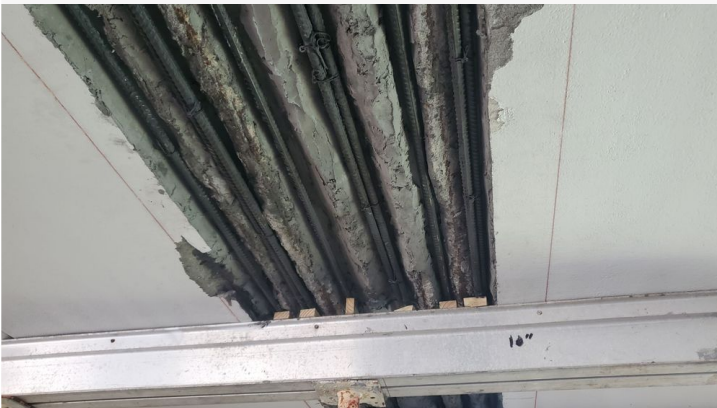
Hollow core repair in progress.

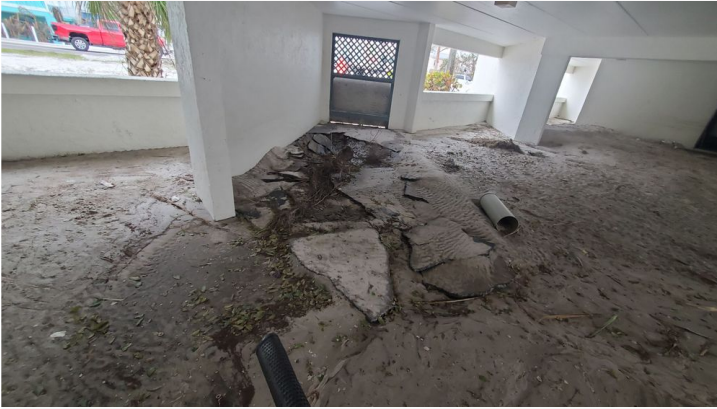
Parking garage asphalt damage following hurricane event.

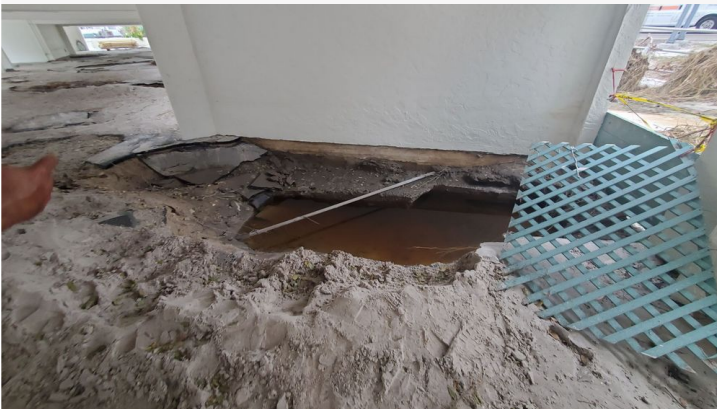
Localized washout of gulf building foundation.

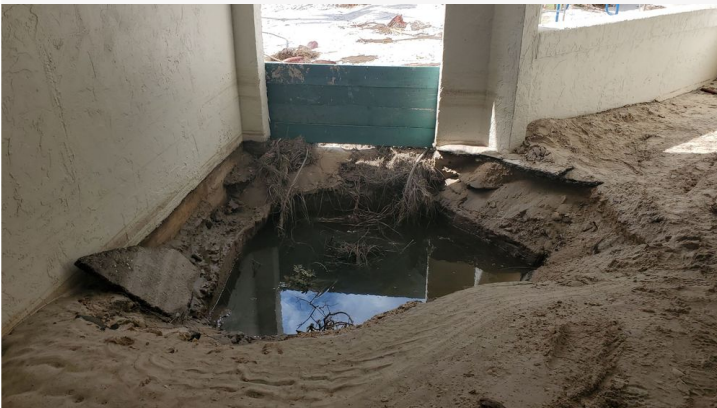
Localized washout of gulf building foundation.

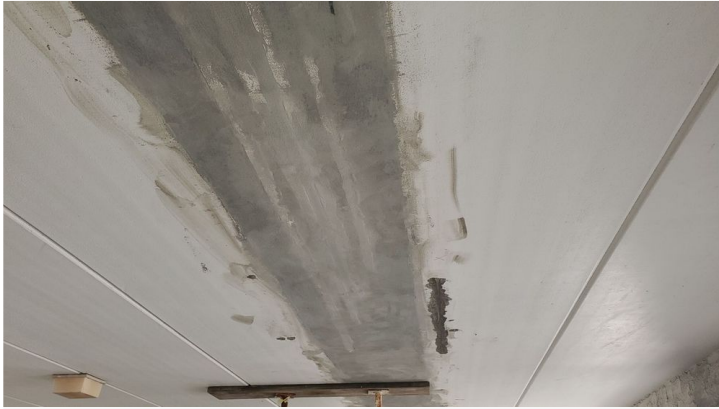
Completed hollow core overhead repair.

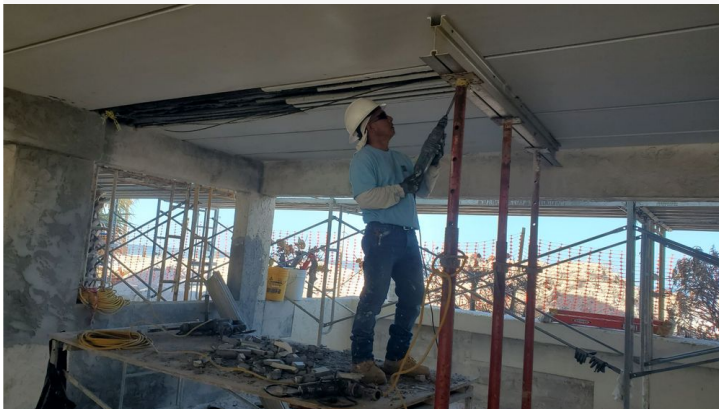
Hollow core repair demo in progress.

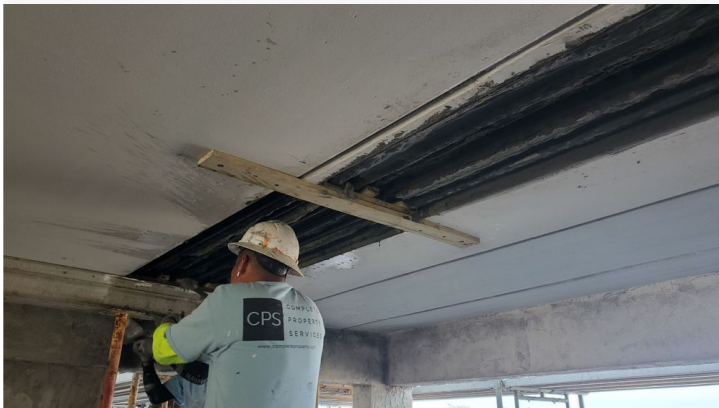
Hollow core repair in progress.
